[Docket No. FAA–2018–0893; Product Identifier 2018–SW–032–AD; Amendment 39–21319; AD 2020–23–03]

#### Airworthiness Directives; Airbus Helicopters

**SUMMARY:** The FAA is superseding Airworthiness Directive (AD) 2017–09–05 for Airbus Helicopters Model AS332C, AS332C1, AS332L, AS332L1, AS332L2, and EC225LP helicopters. AD 2017–09–05 required repetitively checking screws in the emergency flotation gear. This new AD retains the requirements of AD 2017–09–05 but also requires installing a modification (MOD), which is a terminating action for the repetitive checks. This AD was prompted by the development of the MOD by Airbus Helicopters that addresses the unsafe condition. The actions of this AD are intended to address an unsafe condition on these products.

#### 2020–23–03 Airbus Helicopters:

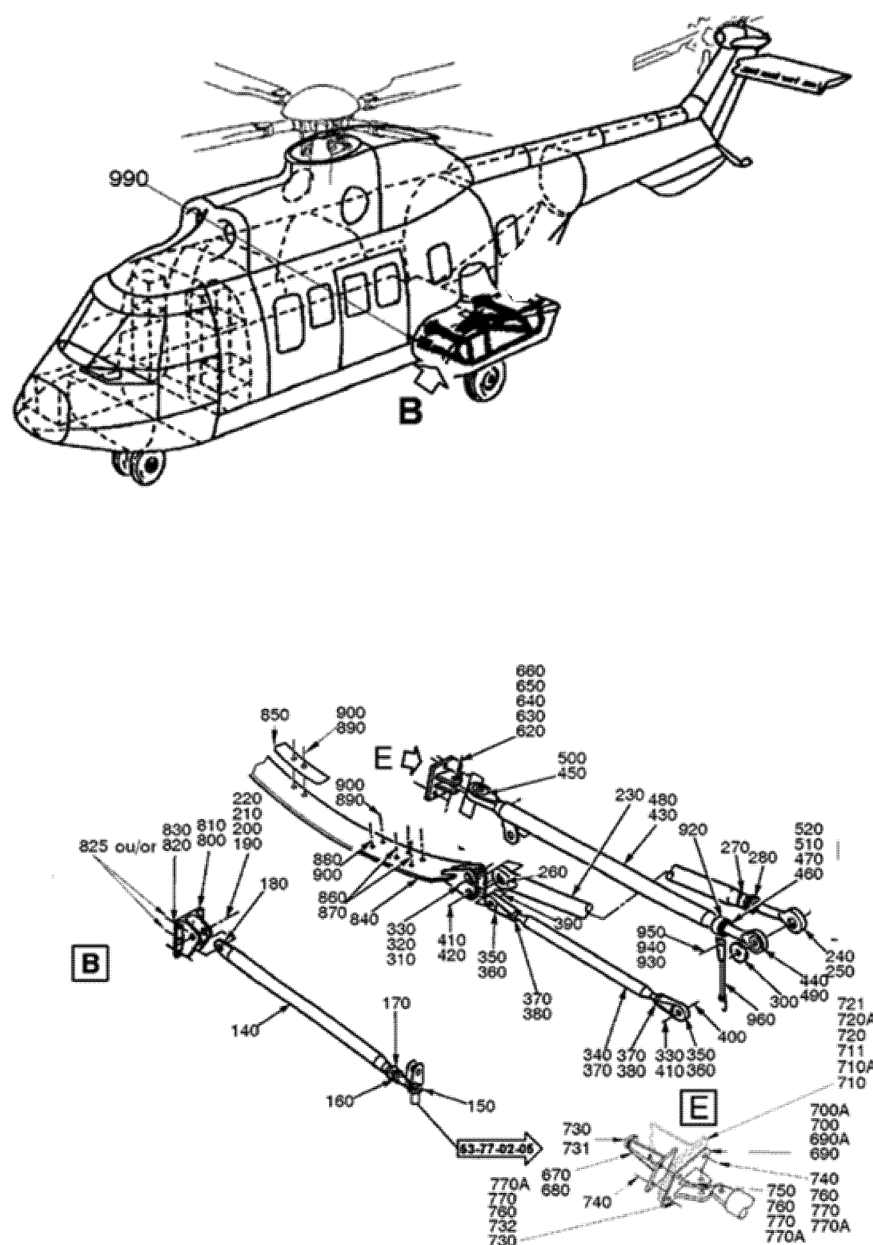
Figure 1 to Paragraph (f)(1)

This AD defines the unsafe condition as failure of a rear upper screw fitting on the emergency flotation gear. This condition, if not detected and corrected, could result in failure of the emergency flotation system and subsequent capsizing of the helicopter.

(1) Within 15 hours time-in-service (TIS), and before each flight over water thereafter, visually check each emergency flotation gear left hand (LH) and right hand (RH) rear upper fitting to determine whether the heads of the lower screws are present. Figure 1 to paragraph (f)(1) of this AD depicts where the lower three screws (noted as B and E) are located. Check each screw for looseness by determining whether it can be rotated by hand. These actions may be performed by the owner/operator (pilot) holding at least a private pilot certificate and must be entered into the aircraft records showing compliance with this AD in accordance with 14 CFR 43.9(a)(1) through (4) and 14 CFR 91.417(a)(2)(v). The record must be maintained as required by 14 CFR 91.417, 121.380, or 135.439.

(2) If a screw head is missing, or if a screw is loose, before further flight over water, install MOD 0728456 by completing paragraph (f)(3) of this AD.

(3) Within 300 hours TIS, unless required before further flight over water by paragraph (f)(2) of this AD, install MOD 0728456 by doing the following:
