[Docket No. FAA-2020-0883; Project Identifier 2019-CE-034-AD; Amendment 39-21460; AD 2021-05-17]

**Airworthiness Directives; Rockwell Collins, Inc. Flight Display System Application**

**ACTION:** Final rule.

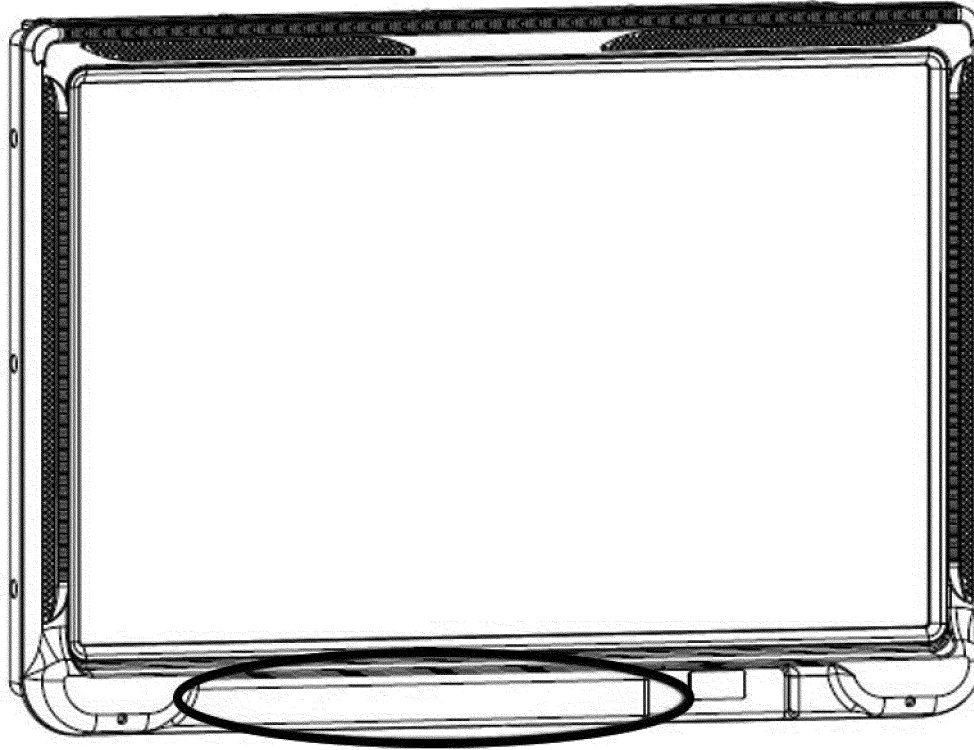
Figure 1 to paragraph (g)(1)(iii); placard location on bezel

This AD was prompted by a conflict between the traffic collision avoidance system (TCAS) primary display indications and aural alerts during a resolution advisory (RA) scenario. The FAA is issuing this AD to prevent conflicting TCAS information, which could result in the pilot under-correcting or over-correcting and may lead to inadequate aircraft separation and a mid-air collision.

(ii) Fabricate a placard for each aircraft primary flight display, using at least 1/8 inch letters, with the following text: TCAS Flight Ops—TA Only mode (TA/RA mode prohibited).

(iii) Install the placard on the bottom of each aircraft primary flight display bezel in the area depicted in figure 1 to paragraph (g)(1)(iii) of this AD.
