[Docket No. FAA-2021-0189; Project Identifier AD-2020-00645-R]

**Airworthiness Directives; Various Restricted Category Helicopters**

**ACTION:** Notice of proposed rulemaking (NPRM).

**SUMMARY:** The FAA proposes to adopt a new airworthiness directive (AD) for type certificated Model UH-1H restricted category helicopters. This proposed AD was prompted by multiple reports of failure of the main driveshaft. This proposed AD would require establishing a life limit for certain main driveshafts, and a one-time and repetitive inspections of the main driveshafts. The FAA is proposing this AD to address the unsafe condition on these products.

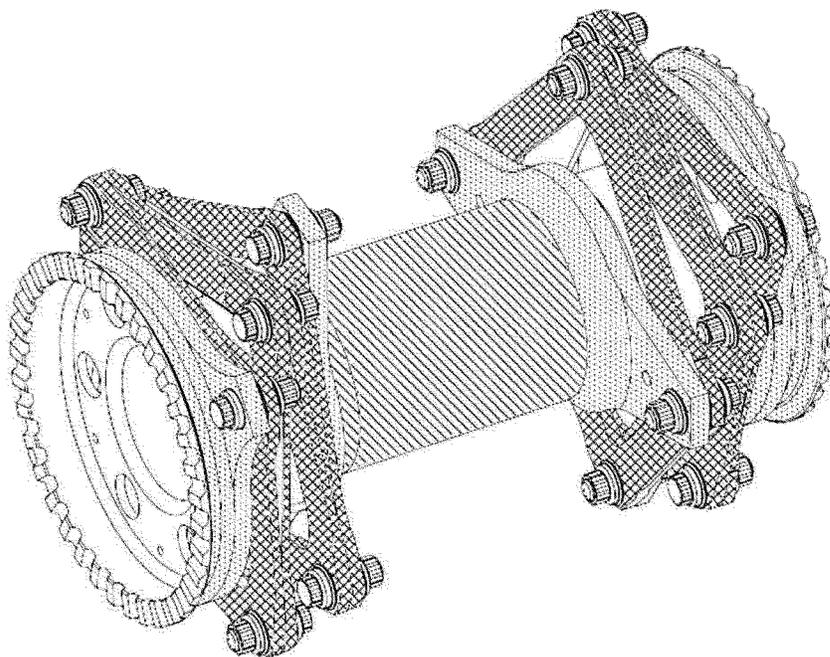
Figure 1 to Paragraph (g)(3)(iv) – Damage Limits

(iv) Inspect the main driveshaft for mechanical damage, corrosion, an edge dent, and nick as shown in Figure 1 to paragraph (g)(3)(iv) of this AD. For the purposes of this inspection, mechanical damage may be indicated by a crack, scratch, or wear; and corrosion may be indicated by corrosion or pitting. If there is a scratch, wear, corrosion, pitting, an edge dent, or a nick within allowable limits, before further flight, repair the main driveshaft in accordance with FAA-approved procedures. If there is a crack, or a scratch, wear, corrosion, pitting, an edge dent, or a nick that exceeds allowable limits, before further flight, replace the driveshaft.

1. No cracks are permitted
2. Repairs must be no less than 1.000 inch apart.
3. Repairs not to be within 0.500 inches of bolt hole.
4. Faying surfaces must be free of any raised metal areas.
5. All repairs to be smooth at maximum depth and smoothly blended with surrounding surface.
6. Exposed bare metal may be touched up with Sermetel Product 1122 or 196. Zinc Chromate, primer color T, even though it does not blend cosmetically with Sermetel coating, can be used if Sermetel touch-up products are unavailable.
