[Docket No. FAA-2020-0442; Project Identifier AD-2020-00260-E; Amendment 39-21640; AD 2021-14-13]

Airworthiness Directives; Pratt & Whitney Turbofan Engines

ACTION: Final rule.

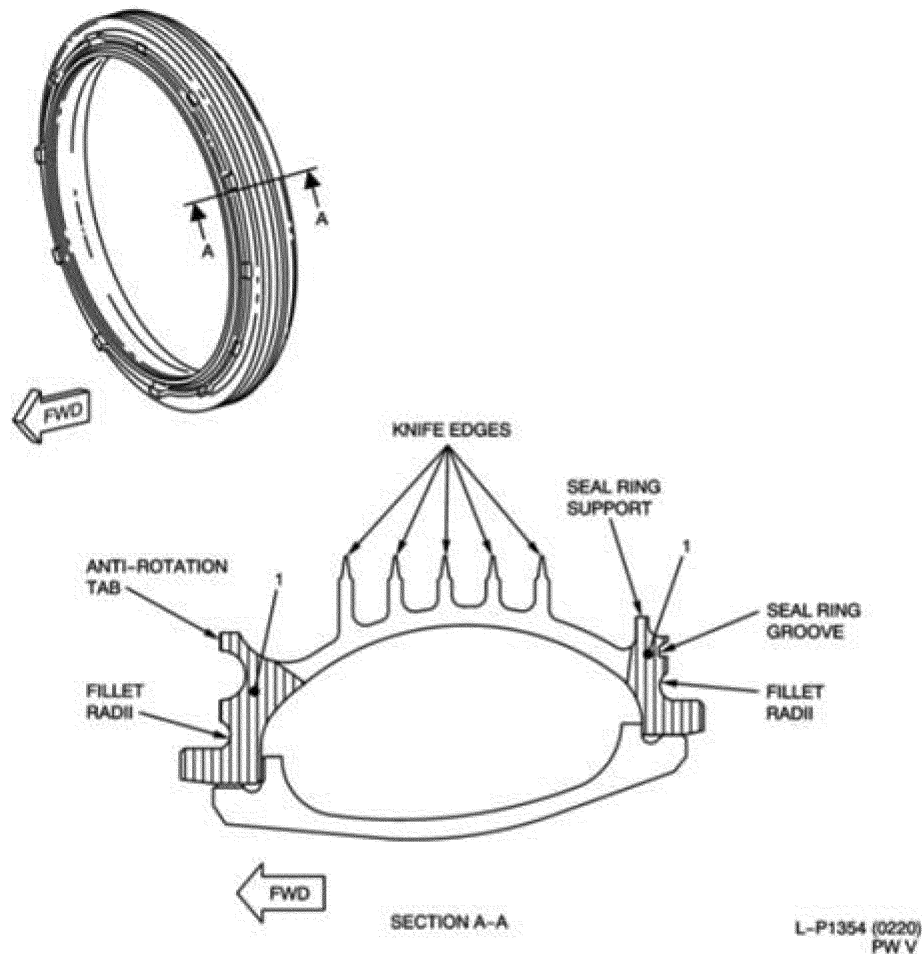
Figure 1 to Paragraph (g)(1)(iii) – Crack Inspection Critical Areas

This AD was prompted by a report of an uncontained engine failure resulting from cracks originating in the knife edge of the high-pressure turbine (HPT) 2nd-stage air seal assembly. The FAA is issuing this AD to prevent failure of the HPT 2nd-stage air seal assembly. The unsafe condition, if not addressed, could result in uncontained HPT 2nd-stage air seal assembly release, damage to the engine, and damage to the airplane.

(iii) During the visual inspection or FPI required by paragraph (g)(1)(i) of this AD, if a crack is found in the shaded regions of the HPT 2nd-stage air seal assembly identified in Figure 1 to paragraph (g)(1)(iii) of this AD (Figure 1), which extends towards the knife-

edge region of the HPT 2nd-stage air seal assembly, remove the HPT 2nd-stage air seal assembly, mating HPT 1st-stage disk, and HPT 2nd-stage hub from service, and replace the parts with parts eligible for installation. In order to return the mating HPT 1st-stage

disk and HPT 2nd-stage hub to service, the inspections of the HPT 2nd-stage air seal assembly cannot reveal a crack identified in the shaded regions of Figure 1, which extends towards the knife-edge region.

If a crack is found as identified in the shaded region of Figure 1 to paragraph (g)(1)(iii) of this AD (Figure 1) that

extends toward the knife-edge region of the HPT 2nd-stage air seal assembly, this AD requires replacement of the HPT 2nd-stage air seal assembly, mating HPT 1st-stage disk, and HPT 2nd-stage hub.
