DEPARTMENT OF TRANSPORTATION**Federal Aviation Administration****14 CFR Part 39**

[Docket No. FAA–2021–0872; Project Identifier MCAI–2021–00312–R]

Airworthiness Directives; Airbus Helicopters

ACTION: Notice of proposed rulemaking (NPRM).

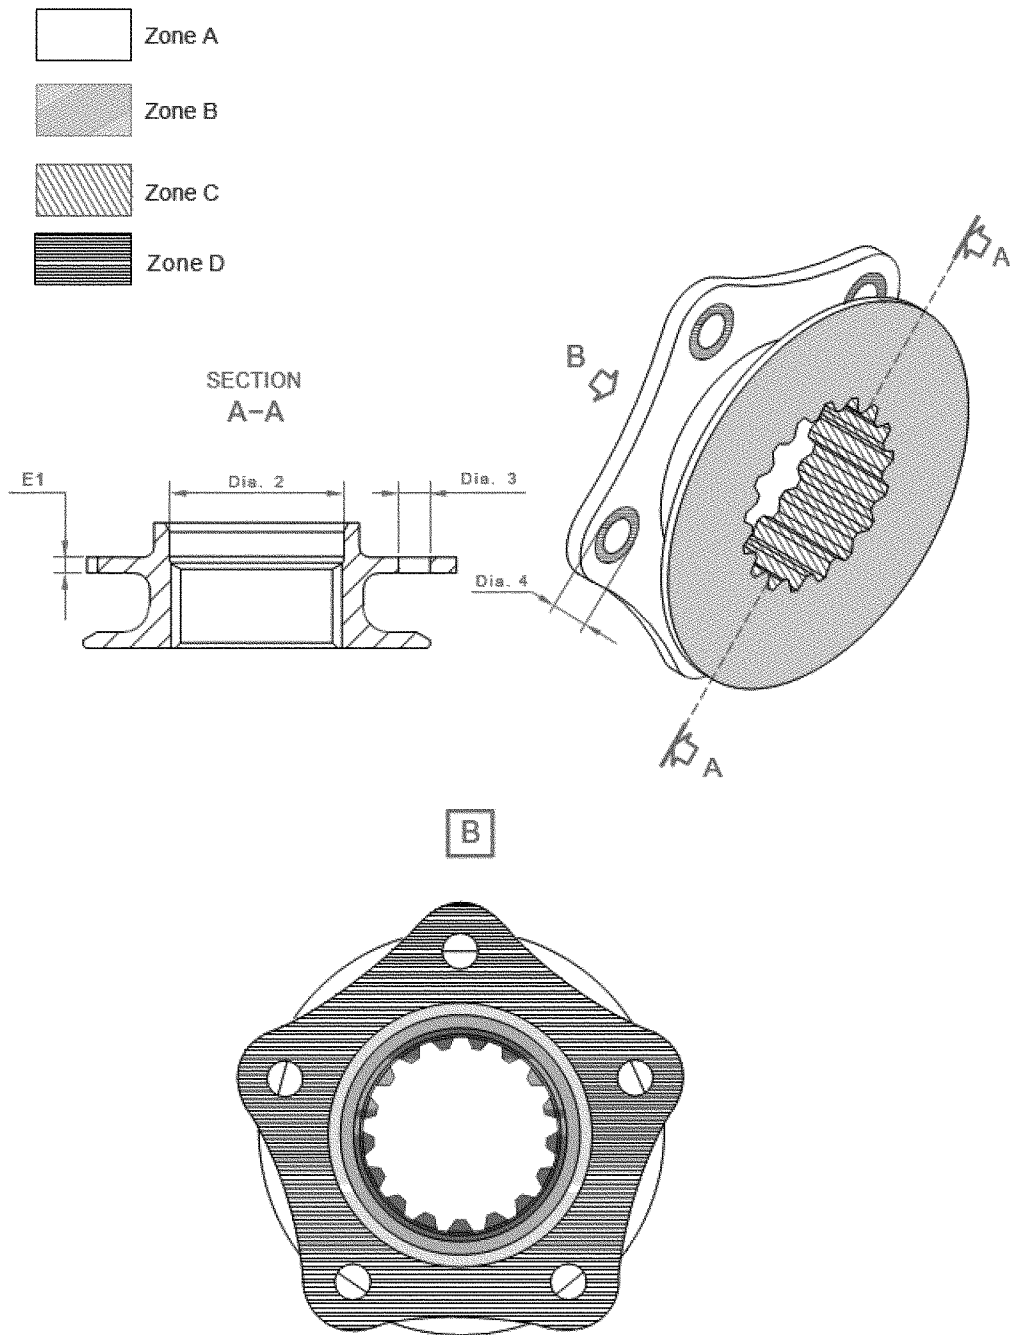
Figure 2 to paragraph (g)(1)(ii) – Inspection Areas of Tail Rotor Splined Flange

(ii) Inspect the TR splined flange for corrosion, impacts, fretting, wear, and a crack in the areas identified in Figure 2 of this AD. If the condition of the part (including corrosion, impacts, fretting, wear, or cracks) exceeds the criteria as specified in Figure 1 of this AD, before further flight, remove the splined flange from service and replace with an airworthy part.

Location as specified in figure 2 to paragraph (g)(1)(ii) of this AD	Maximum damage, which causes replacement (E1, Dia. 2, Dia. 3, and Dia. 4 are shown in figure 2 to paragraph (g)(1)(ii) of this AD)
Zone A	Scratch depth > 0.2 mm (0.008 in.). Crack. E1 < 2.75 mm (0.108 in.). Dia. 3 > 6.02 mm (0.2371 in.). Dia. 2 > 33.03 mm (1.3004 in.).
Zone B	Touch-up depth > 0.1 mm (0.004 in.). Crack.
Zone C	Crack. Scratch depth > 0.2 mm (0.008 in.).
Zone D [Dia. 4 = 14 mm +/- 0.1 mm (0.548; 0.555in.)]	Touch-up depth > 0.1 mm (0.004 in.). Crack. E1 < 2.75 mm (0.108 in.).
