[Docket No. FAA-2021-0872; Project Identifier MCAI-2021-00312-R; Amendment 39-21866; AD 2021-26-07]

Airworthiness Directives; Airbus Helicopters

2021-26-07 Airbus Helicopters:

Joint Aircraft Service Component (JASC) Code: 6400, Tail rotor system.

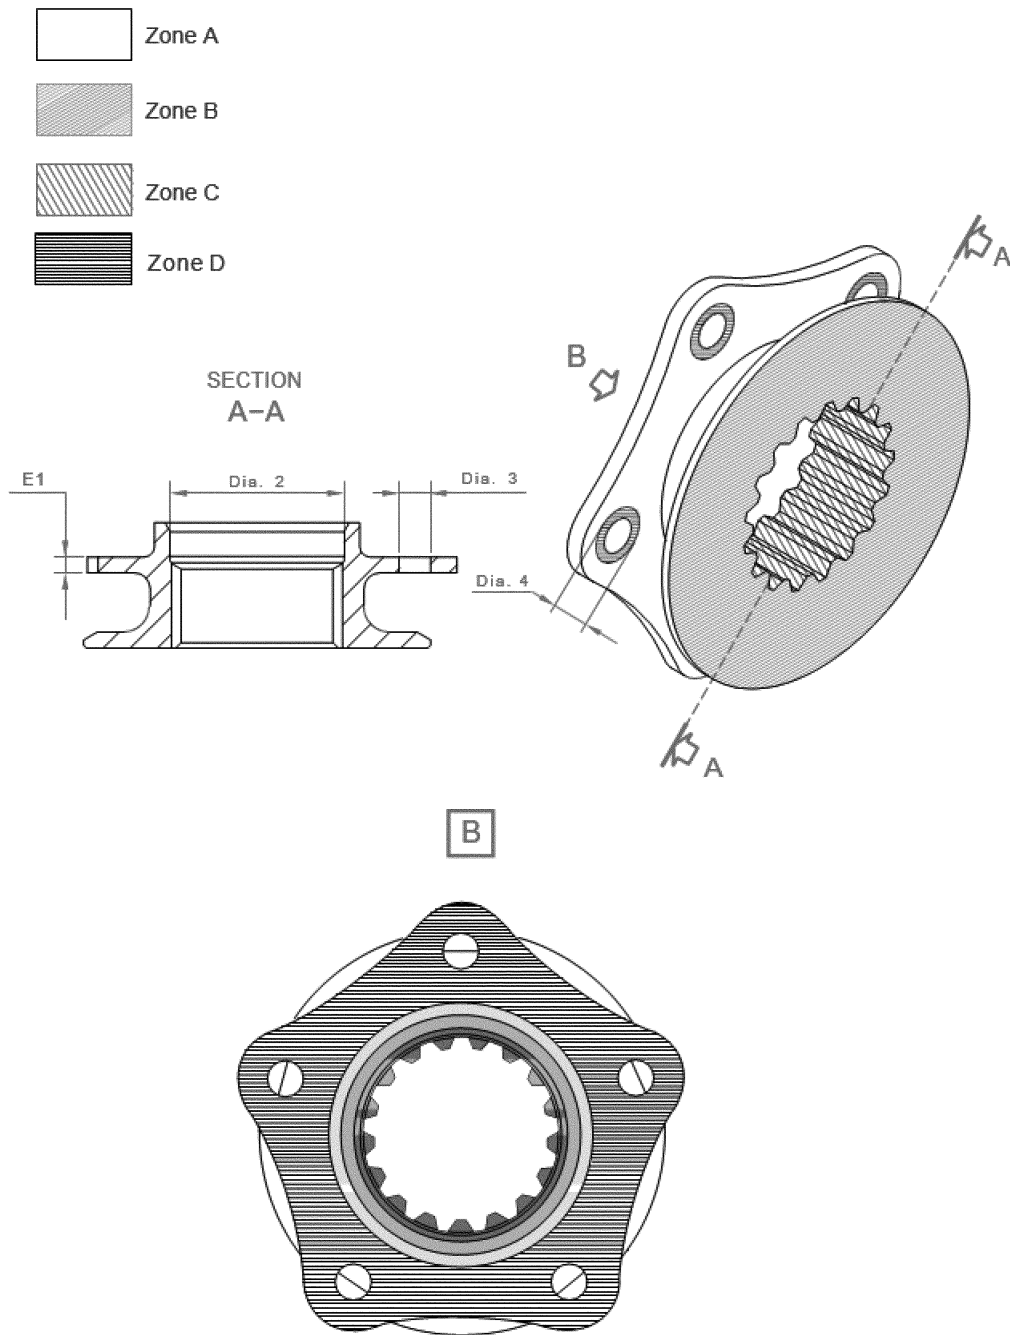
Figure 2 to paragraph (g)(1)(ii) – Inspection Areas of Tail Rotor Splined Flange

attachment bolts on the tail rotor (TR) hub body. The FAA is issuing this AD to detect cracking and fretting, which if not addressed, could result in potential loss of the TR drive and consequent loss of yaw control of the helicopter.

(ii) Inspect the TR splined flange for corrosion, impacts, fretting, wear, and a crack in the areas identified in Figure 2 to paragraph (g)(1)(ii) of this AD. If the condition of the part (including corrosion, impacts, fretting, wear, or cracks) exceeds the criteria as specified in Figure 1 to paragraph (g)(1)(ii) of this AD, before further flight, remove the splined flange from service and replace with an airworthy part.

Location as specified in Figure 2 to paragraph (g)(1)(ii) of this AD	Maximum damage, which causes replacement (E1, Dia. 2, Dia. 3, and Dia. 4 are shown in Figure 2 to paragraph (g)(1)(ii) of this AD)
Zone A	Scratch depth > 0.2 mm (0.008 in.). Crack. E1 < 2.75 mm (0.108 in.). Dia. 3 > 6.02 mm (0.2371 in.). Dia. 2 > 33.03 mm (1.3004 in.).
Zone B	Touch-up depth > 0.1 mm (0.004 in.). Crack.
Zone C	Crack. Scratch depth > 0.2 mm (0.008 in.).
Zone D [Dia. 4 = 14 mm +/- 0.1 mm (0.548; 0.555in.)]	Touch-up depth > 0.1 mm (0.004 in.). Crack. E1 < 2.75 mm (0.108 in.).

(2) For helicopters with 9,000 or more total hours TIS, or with unknown total hours TIS, within 15 hours TIS or 7 days, whichever occurs first after the effective date of this AD, and thereafter at intervals not to exceed 1,000 hours TIS, remove each bolt, washer, and nut installed on the TR hub body from service and replace with airworthy parts and perform the actions in paragraph (g)(1)(ii) of this AD.

(3) For helicopters with less than 9,000 total hours TIS, within 1,000 hours TIS or before accumulating 9,000 total hours TIS, whichever occurs first after the effective date of this AD, and thereafter at intervals not to
