DEPARTMENT OF TRANSPORTATION

Federal Aviation Administration

[Docket No. FAA–2021–0189; Project Identifier AD–2020–00645–R; Amendment 39–21875; AD 2021–26–16]

Airworthiness Directives; Various Restricted Category Helicopters

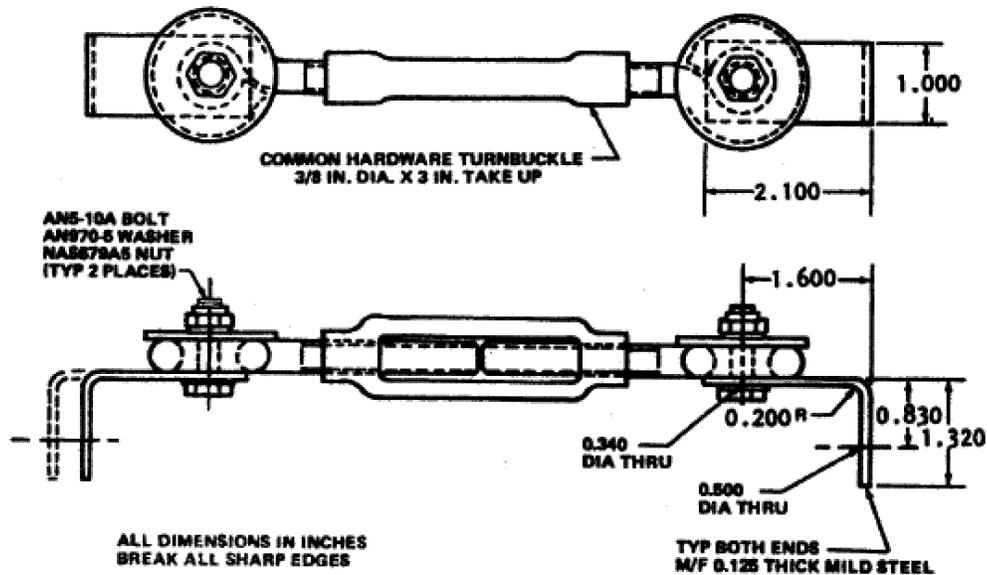
Figure 1 to the Introductory Text of Paragraph (g)(3) – Main Driveshaft Installation and Removal Tool

(3) Within 25 hours TIS after the effective date of this AD, remove main driveshaft P/N SKCP2180–1, SKCP2281–1, SKCP2281–1R, or SKCP2281–103 by following “6–24.3. Removal—Main Driveshaft P/N SKCP2281–103” on page 6–24, including “4–24. Removal—Air Inlet Filters” on page 4–17 and “Figure 4–9. Engine Air Inlet Filter Installation” on page 4–16, of Headquarters, Department of the Army, Aviation Unit and Intermediate Maintenance Instructions Army Model UH–1H/V/EH–1H/X Helicopters, Technical Manual TM 55–1520–210–23–1, Change No. 42, dated April 14, 2003 (TM 55–1520–210–23–1 C 42), except where instructed to “refer to figure 6–12.2” in TM 55–1520–210–23–1 C 42, refer to Figure 1 to the introductory text of paragraph (g)(3) of this AD, and where instructed to “see figure 6–12.3” in TM 55–1520–210–23–1 C 42, see Figure 2 to the introductory text of paragraph (g)(3) of this AD, and:

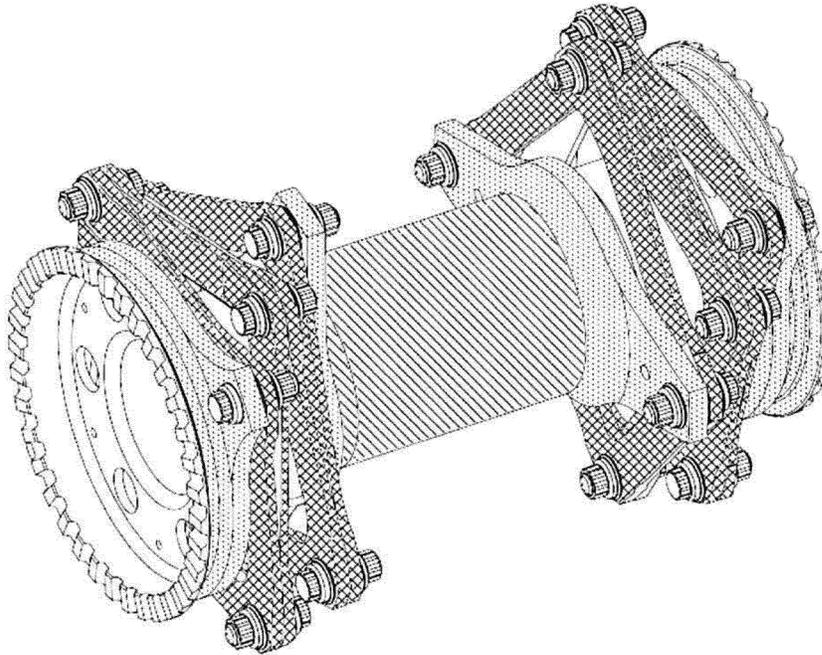
Figure 3 to Paragraph (g)(3)(iv) – Damage Limits

(iv) Inspect the main driveshaft for mechanical damage, corrosion, an edge dent, and nick as shown in Figure 3 to paragraph (g)(3)(iv) of this AD. For the purposes of this inspection, mechanical damage may be indicated by a crack, scratch, or wear; and corrosion may be indicated by corrosion or pitting. If there is a scratch, wear, corrosion, pitting, an edge dent, or a nick within allowable limits, before further flight, repair the main driveshaft in accordance with FAA-approved procedures. If there is a crack, or a scratch, wear, corrosion, pitting, an edge dent, or a nick that exceeds allowable limits,

MECHANICAL	0.001" before and after repair	0.005" before and after repair	0.005" before and after repair	0.015" before and after repair
CORROSION	Surface, no pits	0.005" before and after repair	0.005" before and after repair	0.010" before and after repair
MAXIMUM AREA PER FULL DEPTH REPAIR	0.05 in ²	0.10 in ²	0.25 in ²	0.25 in ²
NUMBER OF REPAIRS	One per leg			
EDGE DENTS, NICKS	0.001 in	0.010 in	0.010 in	0.025 in

1. No cracks are permitted
2. Repairs must be no less than 1.000 inch apart.
3. Repairs not to be within 0.500 inches of bolt hole.
4. Faying surfaces must be free of any raised metal areas.
5. All repairs to be smooth at maximum depth and smoothly blended with surrounding surface.
6. Exposed bare metal may be touched up with Sermetel Product 1122 or 196. Zinc Chromate, primer color T, even though it does not blend cosmetically with Sermetel coating, can be used if Sermetel touch-up products are unavailable.

before further flight, replace the main driveshaft. The main drive shaft may be overhauled in accordance with FAA-

approved procedures to accomplish the replacement required by this paragraph.
