[Docket No. FAA-2023-0430; Project Identifier MCAI-2022-01092-R; Amendment 39-22378; AD 2023-05-09]

Airworthiness Directives; Airbus Helicopters Deutschland GmbH (AHD) Helicopters

ACTION: Final rule; request for comments.

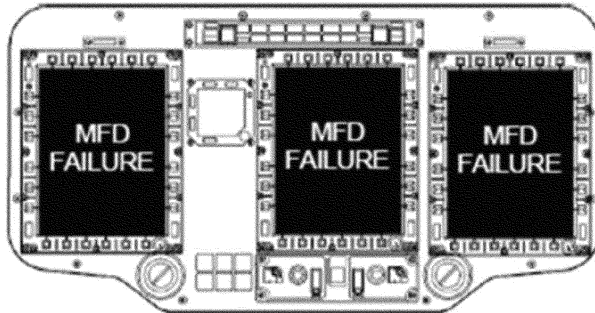
Figure 1 to Paragraph (g)(2): RFM
Emergency Procedure—Model MBB-BK117
Helicopters

- MFD FAILURE displayed on all MFDs
- If autopilot upper modes were coupled, they may decouple after 10 seconds (indicated by an „autopilot decouple“ voice message).

1. Aircraft trajectory - Maintain using IESI and stand-by compass.
- Use AFCS “recovery” or “go-around” modes, if desired
- Operate aircraft within the approved performance
2. MFD2 pb - OFF

4. MFD2 - Maintain in FND format
5. LAND AS SOON AS POSSIBLE

4. VMC conditions – Establish
5. LAND AS SOON AS POSSIBLE
