DEPARTMENT OF TRANSPORTATION

Federal Railroad Administration

Safety Advisory 2023-05; King Pin Assemblies in Highway-Rail Grade Crossing Warning Systems

ACTION: Notice of safety advisory.

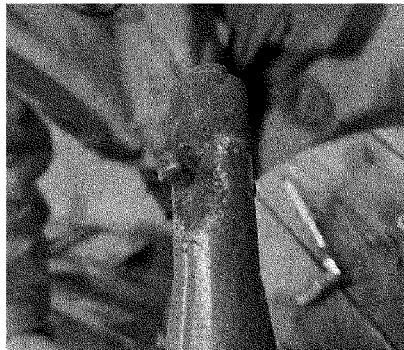
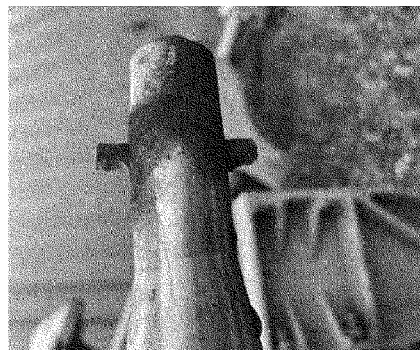
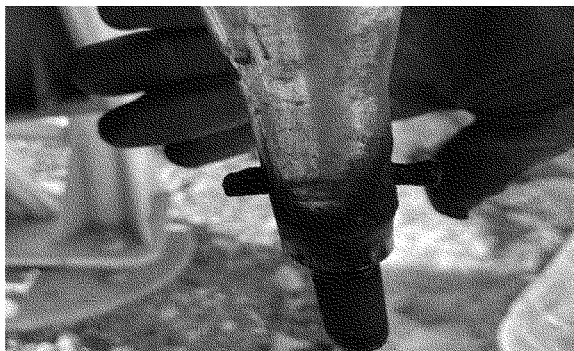
However, the king pin assembly can be damaged under normal operating conditions by vehicle strikes, high winds, rust, worn gate boot(s), and corrosion. If the highway-rail grade crossing gate is being held in place by a worn or damaged king pin assembly, the crossing gate may drop off the king pin and post pin tabs. When this occurs, the crossing gate may be held in place by only the shear bolts, which are not designed to hold the weight of the crossing gate. Therefore, if relied upon to hold the crossing gate in place, the shear bolts could stretch and break unexpectedly, allowing the crossing gate to fall. This could happen very quickly, potentially causing injury to railroad employees or members of the general public in close proximity to the crossing gate.

Figures 4,5,6-Heavily oxidized and worn king pin tabs

(1) Inspect king pin assemblies in highway-rail grade crossing warning systems and replace all worn components.

(2) Develop inspection and maintenance programs for king pin assemblies that incorporate maintenance procedures recommended by the manufacturer (if applicable), including lubrication of king pin assemblies to reduce wear and tear on the components. These inspection and maintenance programs should include periodic inspections of the king pin assembly with the crossing gate removed, as well as inspection of the king pin assembly each time the crossing gate is re-hung or replaced. These inspection and maintenance programs should also address the replacement of worn components and give special consideration to highway-

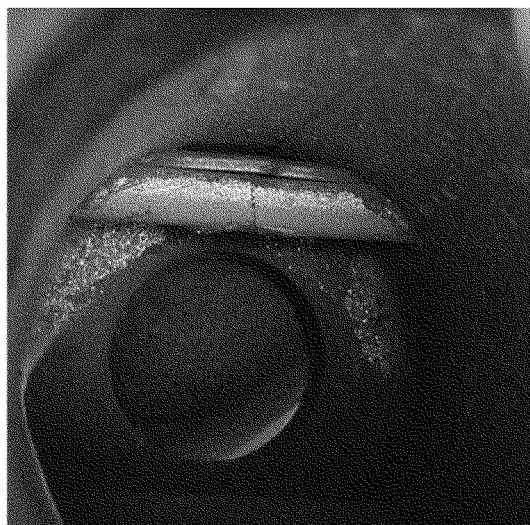
Figure 7-Roll pin crack on king pin
