**Airworthiness Directives; Robinson Helicopter Company Helicopters**

**ACTION:** Notice of proposed rulemaking (NPRM).

**Robinson Helicopter Company:** Docket No. FAA-2023-2232; Project Identifier AD-2023-00943-R.

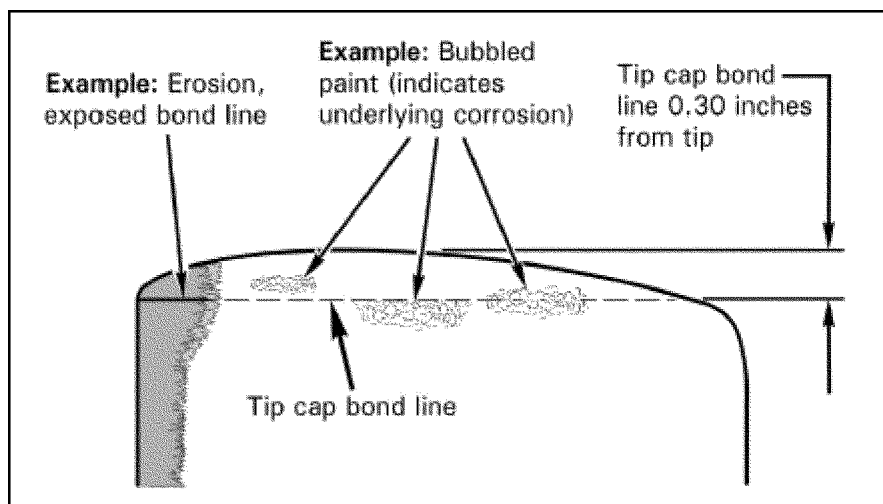
Figure 1 to Paragraph (g)(1)—TRB Tip Cap Check/Inspection

The FAA has received three reports of TRB tip caps coming loose due to corrosion at the bond on Robinson Helicopter Company Model R44 helicopters. Due to the similarity of the TRB tip caps on Robinson Helicopter Company Model R22, R22 Alpha, R22 Beta, R22 Mariner, R44 II, and R66 helicopters, those model helicopters are also affected by this issue. According to Robinson Helicopter Company, it has also seen TRBs that have corroded to an unserviceable condition, including severe leading edge pitting and degradation of the bond at the tip cap. Robinson Helicopter Company advises that helicopters operating near saltwater are particularly susceptible to corrosion, especially if stored outdoors. Affected TRBs were factory-installed or shipped as spares prior to November 2022. The three reports include a TRB tip cap departing its helicopter. The separate incidents occurred during a run-up check, after landing, and during a landing on different helicopters. Accordingly, this proposed AD would require repetitively checking and inspecting the tips caps of TRB part number (P/N) A029-2 with TRB serial numbers (S/N) up to 11279 inclusive (P/N A029-2 REV A through U inclusive), TRB P/N C029-3 with TRB S/N up to 14329 inclusive (P/N C029-3 REV A through Q inclusive), and TRB P/N F029-1 with TRB S/N up to 3099 inclusive (P/N F029-1 REV A through F inclusive) for evidence of corrosion, removing corrosion, and eventual removal of those TRBs from service.

A debonded TRB tip cap can cause severe vibration and possible failure of the tail rotor gearbox housing. This condition, if not addressed, could result in increased vibrations, reduced controllability, and subsequent loss of control of the helicopter.

(1) Within 10 hours time-in-service (TIS) after the effective date of this AD and thereafter before the first flight of each day, visually check each TRB tip cap area (at and adjacent to the tip cap bond line on each surface and edge of the TRB) for an exposed tip cap bond line or bubbled paint, as depicted in Figure 1 of paragraph (g)(1) of this AD. These items may indicate evidence of corrosion. The owner/operator (pilot) holding at least a private pilot certificate may accomplish this TRB tip cap check and must enter compliance with this paragraph of the AD into the helicopter maintenance records in accordance with 14 CFR 43.9(a) and 91.417(a)(2)(v). The record must be maintained as required by 14 CFR 91.417, 121.380, or 135.439.

(2) Within 100 hours TIS or during the next 100 hour or annual inspection after the effective date of this AD, whichever occurs first, and thereafter at intervals not to exceed 100 hours TIS or during the next 100 hour or annual inspection, whichever occurs first, visually inspect each TRB tip cap area (at and adjacent to the tip cap bond line on each surface and edge of the TRB) for evidence of corrosion, which may be indicated by an exposed tip cap bond line or bubbled paint, as depicted in Figure 1 of paragraph (g)(1) of this AD.

(3) As a result of the actions required by either paragraph (g)(1) or (2) of this AD, if there is evidence of corrosion, an exposed tip cap bond line, or bubbled paint, before further flight, remove all of the corrosion.

(4) Within 10 months of the effective date of this AD, remove all TRBs identified in paragraph (c) of this AD from service.
