[Docket No. FAA-2023-1993; Project Identifier AD-2023-00129-T]

Airworthiness Directives; The Boeing Company Airplanes**AGENCY:** Federal Aviation Administration (FAA), DOT.**ACTION:** Notice of proposed rulemaking (NPRM).

The Boeing Company: Docket No. FAA–2023–1993; Project Identifier AD–2023–00129–T.

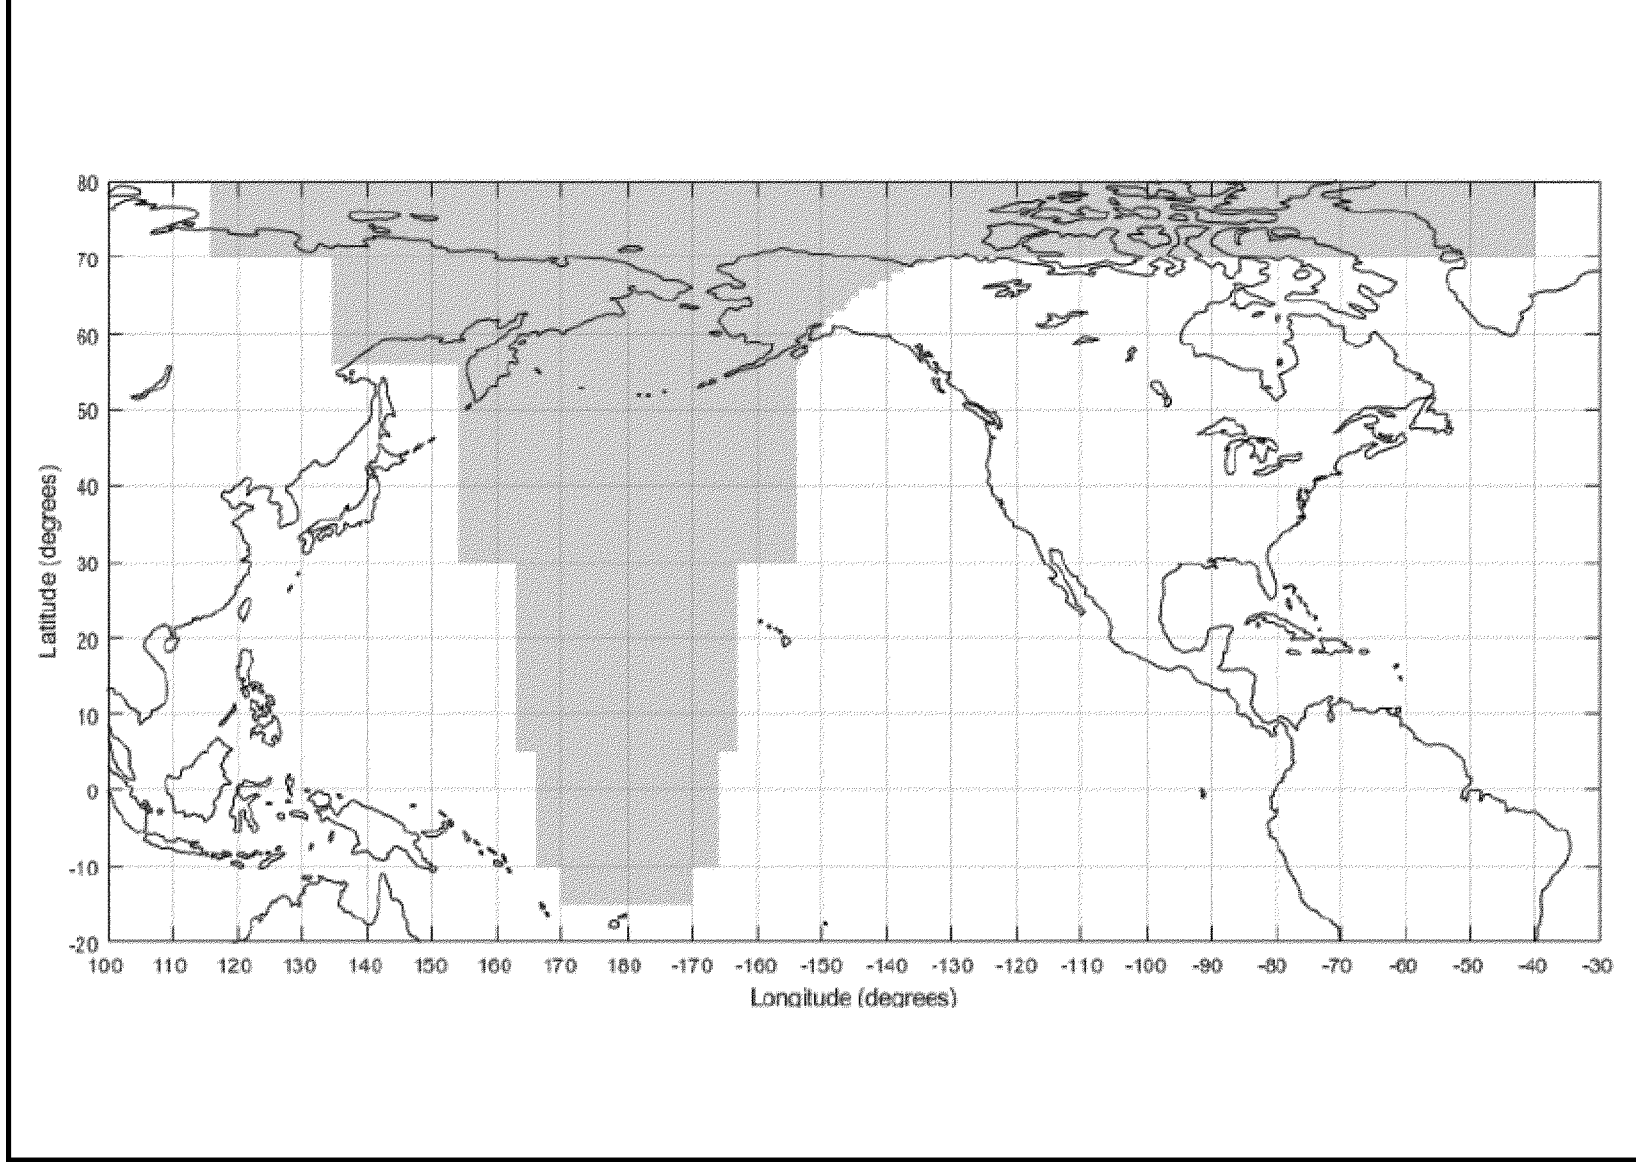
Figure 2 to Paragraph (g)—AFM—
Limitations or Certificate Limitations
Continued

Operations that require less than 0.3 RNP (For example, 0.1, 0.11, 0.15, etc.) in the region identified below are prohibited with GLU-2100 OPS software number COL4D-0087-0002, COL4E-0087-0001, COL48-0087-0700, or COL49-0087-0701 installed.

Exception: Anchorage (PANC) approach procedures that allow less than RNP 0.3 are authorized provided the instructions outlined in the Electronics – Global Landing Unit Section of Normal Procedures Chapter are followed.

Note: Currently, Fairbanks (PAFA) and Anchorage (PANC) are the only airports in the region with an RNP approach that requires better than 0.3 nmi performance.

Region bounded by the following coordinates:

Latitude Range (degrees)	Longitude Range (degrees)
80 N to 70 N	40 E to 40 W
70 N to 69 N	134.5 E to 134.38 W
69 N to 68 N	134.5 E to 137.28 W
68 N to 67 N	134.5 E to 139.50 W
67 N to 66 N	134.5 E to 141.58 W
66 N to 65 N	134.5 E to 144.23 W
65 N to 64 N	134.5 E to 145.48 W
64 N to 63 N	134.5 E to 146.44 W
63 N to 62 N	134.5 E to 148.33 W
62 N to 61 N	134.5 E to 149.50 W
61 N to 60 N	134.5 E to 150.35 W
60 N to 59 N	134.5 E to 151.00 W
59 N to 58 N	134.5 E to 151.40 W
58 N to 57 N	134.5 E to 152.62 W
57 N to 56 N	134.5 E to 153.42 W
56 N to 30 N	154 E to 154 W
30 N to 5 N	163 E to 163 W
5 N to 10 S	166 E to 166 W
10 S to 15 S	170 E to 170 W
