[Docket No. FAA–2023–2232; Project Identifier AD–2023–00943–R; Amendment 39–22681; AD 2024–04–02]

Airworthiness Directives; Robinson Helicopter Company Helicopters

2024-04-02 Robinson Helicopter Company:
Amendment 39-22681; Docket No. FAA-2023-2232; Project Identifier AD-2023-00943-R.

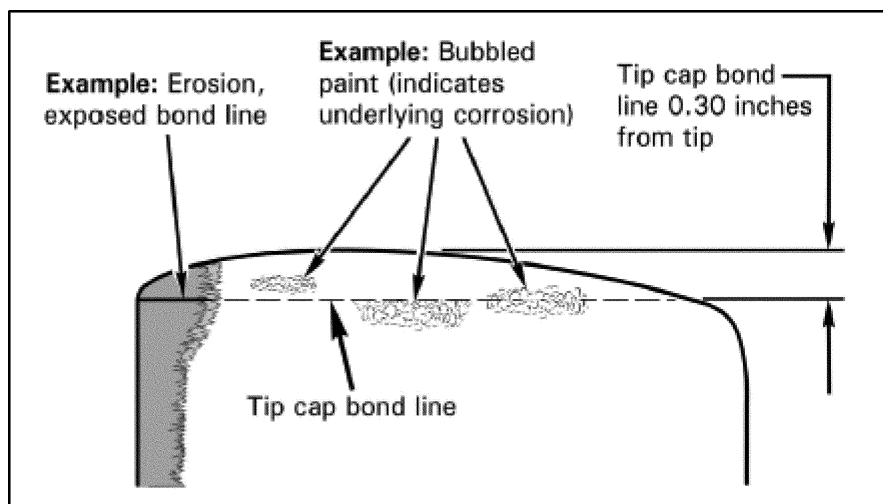
Figure 1 to Paragraph (g)(1)—TRB Tip Cap Check/Inspection

This AD was prompted by reports of helicopters losing a TRB tip cap. The FAA is issuing this AD to detect and prevent TRB tip cap failures. The unsafe condition, if not addressed, could result in increased vibrations, reduced controllability, and subsequent loss of control of the helicopter.

(1) Within 10 hours time-in-service (TIS) after the effective date of this AD and thereafter before the first flight of each day, visually check each TRB tip cap area (at and adjacent to the tip cap bond line on each surface and edge of the TRB) for an exposed tip cap bond line or bubbled paint, as depicted in Figure 1 to paragraph (g)(1) of this AD. These items may indicate evidence of corrosion. The owner/operator (pilot) holding at least a private pilot certificate may accomplish this TRB tip cap check and must enter compliance with this paragraph of the AD into the helicopter maintenance records in accordance with 14 CFR 43.9(a) and 91.417(a)(2)(v). The record must be maintained as required by 14 CFR 91.417, 121.380, or 135.439.

(2) Within 100 hours TIS or during the next 100 hour or annual inspection after the effective date of this AD, whichever occurs first, and thereafter at intervals not to exceed 100 hours TIS or during the next 100 hour or annual inspection, whichever occurs first, visually inspect each TRB tip cap area (at and adjacent to the tip cap bond line on each surface and edge of the TRB) for evidence of corrosion, which may be indicated by an exposed tip cap bond line or bubbled paint, as depicted in Figure 1 to paragraph (g)(1) of this AD.

(3) As a result of the actions required by either paragraph (g)(1) or (2) of this AD, if there is evidence of corrosion, an exposed tip cap bond line, or bubbled paint, before further flight, remove all of the corrosion.

(4) Within 10 months of the effective date of this AD, remove all TRBs identified in paragraph (c) of this AD from service.
