Federal Register

[Docket No. FAA-2024-0237; Project Identifier AD-2023-00491-R]

Airworthiness Directives; Robinson Helicopter Company Helicopters

ACTION: Notice of proposed rulemaking (NPRM).

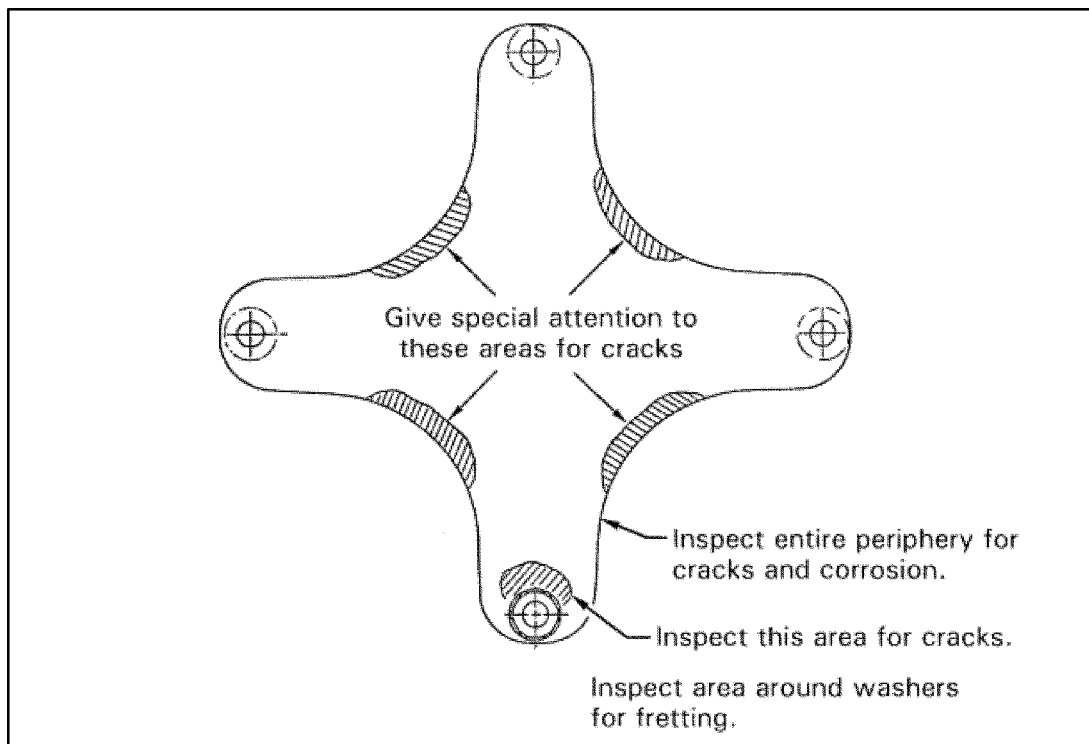
Figure 1 to Paragraph (g)(1)(i)—Flex Plate Inspection

(i) Visually inspect forward flex plate assembly (flex plate) part number (P/N) C947–1 for any loose fasteners, cracks, fretting, corrosion, wear, and to ensure that the washers are bonded to both sides of each flex plate arm, in the areas depicted in Figure 1 to paragraph (g)(1)(i) of this AD, which includes the four bolt holes. If there is any loose fastener (can be moved by hand), crack, fretting, corrosion, or wear in any area including the four bolt holes, or wear that consists of the washers not securely bonded to both sides of each flex plate arm, before further flight, remove the flex plate from service and replace with an airworthy flex plate.
