[Docket No. FAA-2024-0769; Project Identifier AD-2023-00556-T]

Airworthiness Directives; The Boeing Company Airplanes

ACTION: Notice of proposed rulemaking (NPRM).

SUMMARY: The FAA proposes to adopt a new airworthiness directive (AD) for certain The Boeing Company Model 777 airplanes. This proposed AD was prompted by a report indicating multiple findings of cracks in the fuselage skin common to the underwing longeron (UWL). This proposed AD would require external or internal (depending on configuration) inspections for any cracking of the left and right side fuselage skin common to the UWL, and applicable on-condition actions. The FAA is proposing this AD to address the unsafe condition on these products.

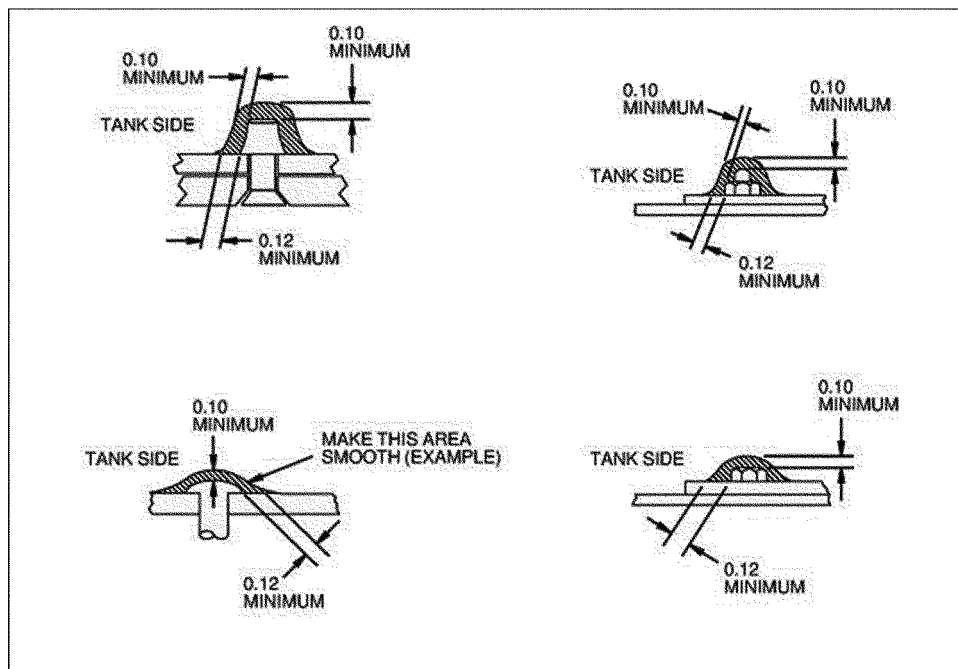
Figure 1 to Paragraph (h)(3)—Cap Sealing Dimensions (all Dimensions are in Inches)

(3) Where any service information referenced in Boeing Alert Requirements Bulletin 777–53A0100 RB, dated March 16, 2023, specifies applying a cap seal (sealant) to a fastener, fastener head, and fastener threads and collars, for this AD, during application of any cap seal to a fastener, fastener head, or fastener threads and collars, the cap seal must be applied using a cap sealing procedure with thickness greater than or equal to the dimensions given in Figure 1 to paragraph (h)(3) of this AD.

heads, and fastener threads and collars for the airplane groups and configurations identified in paragraphs (h)(6)(ii)(A) through (D) of this AD. For those airplane groups and configurations, the application of a cap seal to the underwing longeron fasteners at the locations identified in Figures 81 and 144 is required during installation of the underwing longeron and must be applied using a cap sealing procedure with thickness greater than or equal to the dimensions given in Figure 1 to paragraph (h)(3) of this AD.

(iii) For any inspection that may require the removal of fastener cap seals, if the cap seal is removed, a cap seal of BMS 5-45 sealant must be reapplied using a cap sealing procedure with a thickness equal to or greater than the dimensions specified in Figure 1 to paragraph (h)(3) of this AD before further flight after completion of the inspection.
