Federal Aviation Administration

[Docket No. FAA-2024-2011; Project Identifier AD-2023-01121-R]

Airworthiness Directives; MD Helicopters, LLC, Helicopters

ACTION: Notice of proposed rulemaking (NPRM).

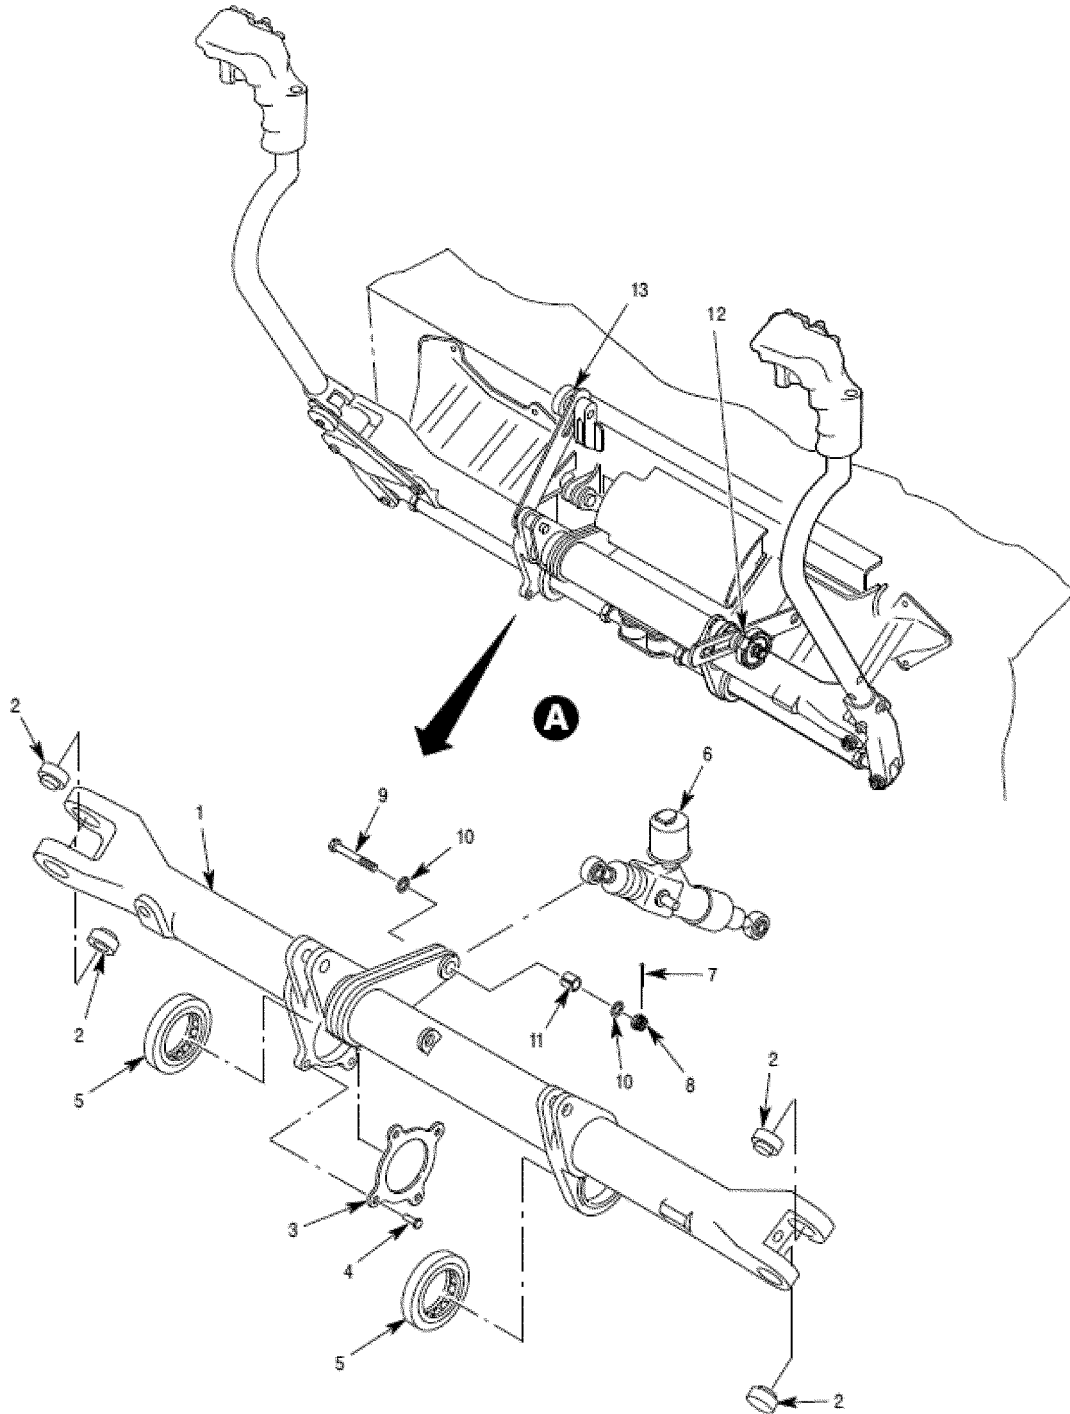
(ii) Visually inspect each roller bearing (number 5) as depicted in Figure 1 to paragraph (g)(1) of this AD for corrosion and degradation. If a roller bearing has any corrosion or degradation, before further flight, remove the roller bearing from service and install an airworthy roller bearing.

(i) Disconnect the one-way lock (number 6) of the torque tube by removing the cotter pin (number 7), nut (number 8), bolt (number 9), washers (number 10), and slotted bushing

(number 11) from the torque tube assembly as depicted in Figure 1 to paragraph (g)(1) of this AD.

(ii) Loosen the longitudinal cyclic friction knob (number 12 or 13) of the torque tube assembly as depicted in Figure 1 to paragraph (g)(1) of this AD.

(g)(2)(iii) of this AD, before further flight, inspect each roller bearing (number 5) as depicted in Figure 1 to paragraph (g)(1) of this AD for damage. For the purposes of this inspection, damage may be indicated by corrosion, lack of lubrication (dry exterior surface), or material degradation.

(B) If any roller bearing (number 5) as depicted in Figure 1 to paragraph (g)(1) of this AD has any damage, before further flight, remove the roller bearing from service and install an airworthy roller bearing.

paragraph (g)(2)(iii) of this AD or after accomplishing the action required by paragraph (g)(2)(iii)(B) of this AD, as applicable, tighten the cyclic friction knob (number 12 or 13) as depicted in Figure 1 to paragraph (g)(1) of this AD.

(v) Connect the one-way lock (number 6) as depicted in Figure 1 to paragraph (g)(1) of this AD by accomplishing the actions required by paragraphs (g)(2)(v)(A) and (B).

(A) Install the slotted bushing (number 11), washers (number 10), bolt (number 9), nut (number 8), and new (zero total hours TIS) cotter pin (number 7) as depicted in Figure 1 to paragraph (g)(1) of this AD.

(B) Ensure the edge of the slotted bushing (number 11) protrudes 0.010 to 0.080 inch (0.25 to 2.03 mm) above the surface of the cyclic torque tube after the nut is tightened.
