DEPARTMENT OF TRANSPORTATION**Federal Aviation Administration****14 CFR Part 39**

[Docket No. FAA–2024–0237; Project Identifier AD–2023–00491–R; Amendment 39–22853; AD 2024–19–11]

Airworthiness Directives; Robinson Helicopter Company Helicopters

2024-19-11 Robinson Helicopter Company: Amendment 39-22853; Docket No. FAA-2024-0237; Project Identifier AD-2023-00491-R.

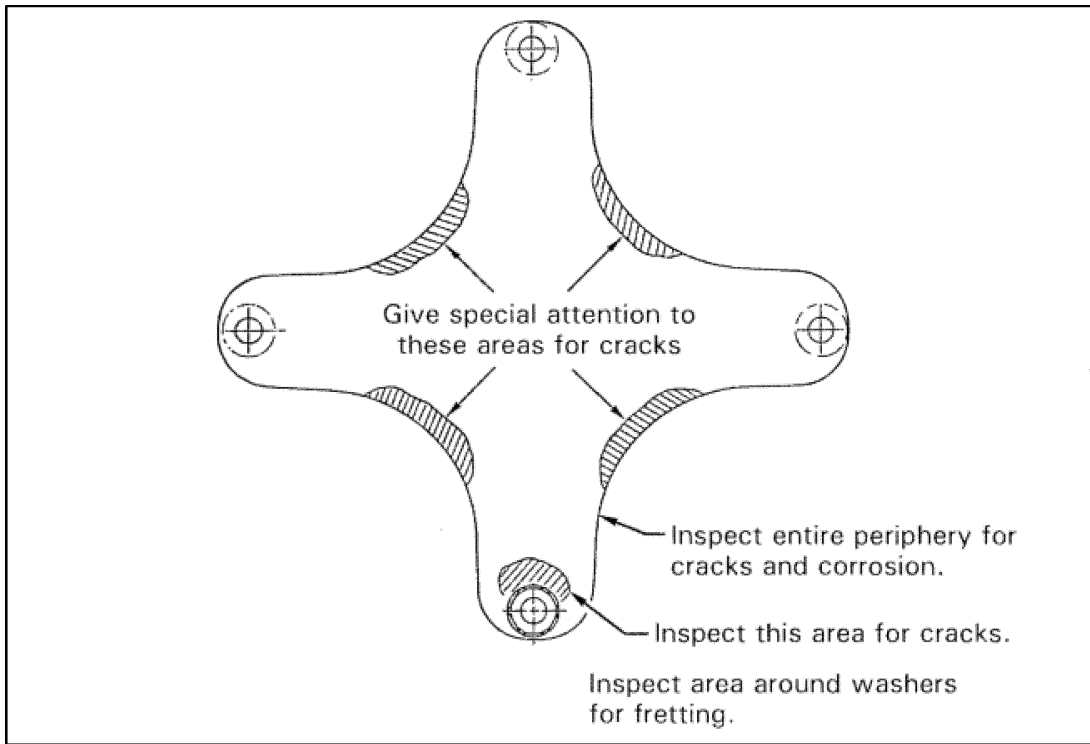
Figure 1 to Paragraph (g)(1)(i)—Flex Plate Inspection

(i) Visually inspect forward flex plate assembly (flex plate) part number (P/N) C947-1 for any loose fasteners, cracks, fretting, corrosion, wear, and to ensure that the washers are bonded to both sides of each flex plate arm, in the areas depicted in Figure 1 to paragraph (g)(1)(i) of this AD. If there is any loose fastener (can be moved by hand), crack, fretting, corrosion, or wear that consists of the washers not securely bonded to both sides of each flex plate arm, before further flight, remove the flex plate from service and replace with an airworthy flex plate.
