[Docket No. FAA-2024-0769; Project Identifier AD-2023-00556-T; Amendment 39-22815; AD 2024-16-09]

Airworthiness Directives; The Boeing Company Airplanes

SUMMARY: The FAA is adopting a new airworthiness directive (AD) for certain The Boeing Company Model 777-200, -200LR, -300, -300ER, and 777F series airplanes. This AD was prompted by a report indicating multiple findings of cracks in the fuselage skin common to the underwing longeron (UWL). This AD requires external or internal (depending on configuration) inspections for any cracking of the left and right side fuselage skin common to the UWL, and applicable on-condition actions. The FAA is issuing this AD to address the unsafe condition on these products.

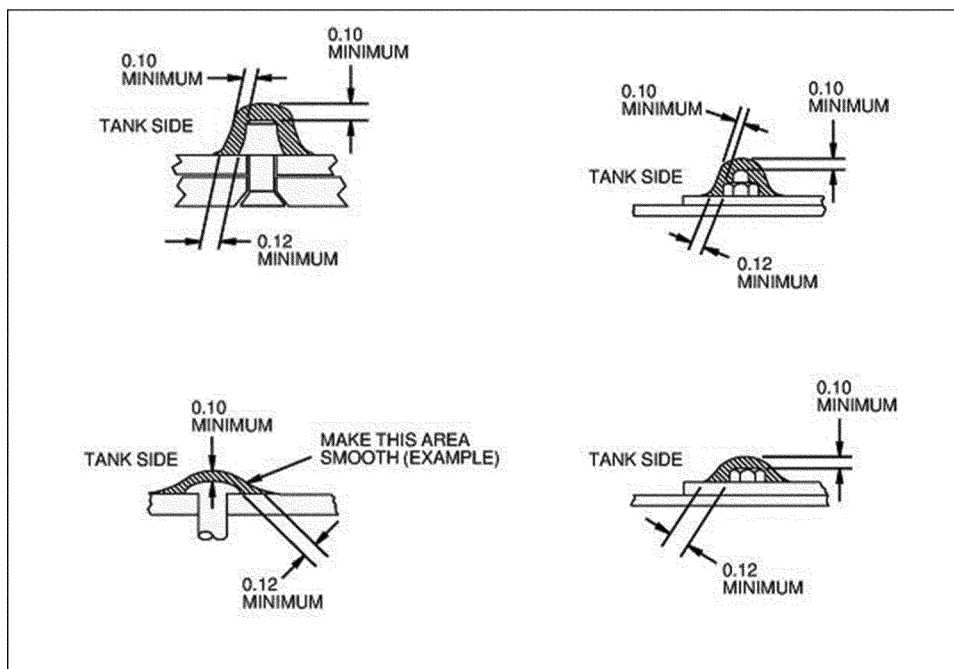
Figure 1 to Paragraph (h)(3)—Cap Sealing Dimensions (all Dimensions are in Inches)

Boeing concluded that only the cap seals on the interior side of the fuel tank require the dimensions specified in Figure 1 of paragraph (h)(3) of the proposed AD to perform their intended function, which is consistent with the labels shown in Figure 1 of paragraph (h)(3) of the proposed AD. Boeing recommended replacing the text “applying a cap seal (sealant) to a fastener, fastener head, and fastener threads and collars, for this AD, during application of any cap seal to a fastener, fastener head, or fastener threads and collars” with the text “applying a cap seal (sealant) to a fastener location that penetrates the fuel tank boundary, for

The FAA agrees. Boeing 777 AMM 28–11–00 meets the sealant requirements of Figure 1 to paragraph (h)(3) of this AD. As such, it would be an acceptable procedure to follow when sealing inside the fuel tank in accordance with paragraph (h)(3) of this AD. The FAA has added a note to paragraph (h)(3) of this AD accordingly.

Note 4 to paragraph (h)(3): Guidance on an acceptable cap sealing procedure for accomplishing the actions required by paragraph (h)(3) of this AD can be found in Boeing Model 777 Aircraft Maintenance Manual (AMM) section 28–11–00.
