[Docket No. FAA–2024–1896; Project Identifier MCAI–2023–00978–T; Amendment 39–22966; AD 2025–04–08]

Airworthiness Directives; MHI RJ Aviation ULC (Type Certificate Previously Held by Bombardier Inc.) Airplanes

ACTION: Final rule.

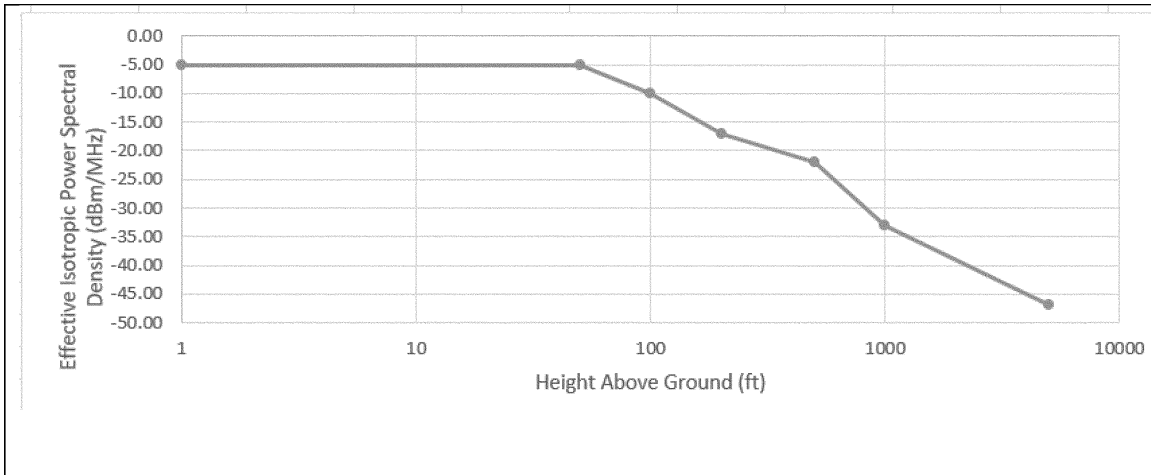
Figure 1 to Paragraph (g)(1)—Fundamental Effective Isotropic PSD at Outside Interface of Airplane Antenna

(1) Tolerance to radio altimeter interference, for the fundamental emissions (3.7–3.98 GHz), at or above the power

spectral density (PSD) curve threshold specified in figure 1 to paragraph (g)(1) of this AD.

Height above ground (ft)	Effective Isotropic PSD (dBm/MHz)
Airplanes on the ground	-5
50	-5
100	-10
200	-17
500	-22
1000	-33
5000	-47

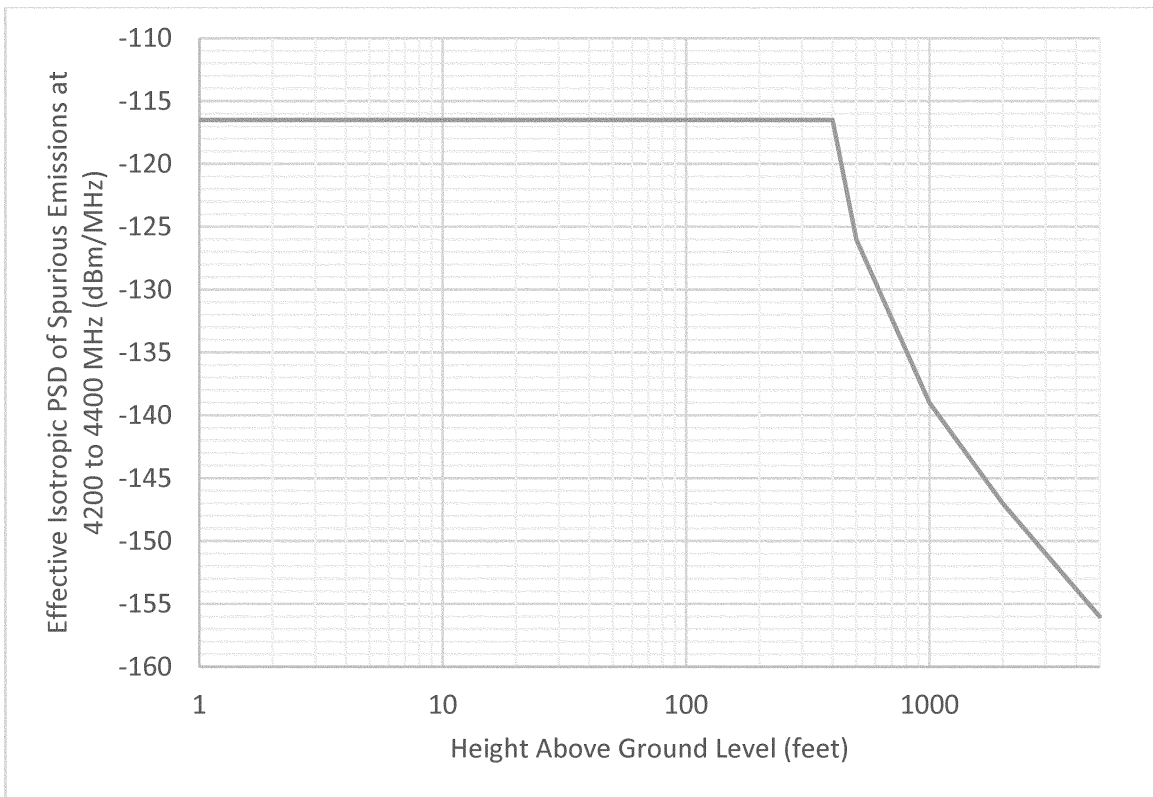
Figure 2 to Paragraph (g)(2)—Spurious Effective Isotropic PSD at Outside Interface of Airplane Antenna

(2) Tolerance to radio altimeter interference, for the spurious emissions (4.2–4.4 GHz), at or above the PSD curve threshold

specified in figure 2 to paragraph (g)(2) of this AD.

Airplane Altitude (ft AGL)	Effective Isotropic PSD (dBm/MHz)
1	-116.50
400	-116.50
500	-126.00
1000	-139.00
2000	-147.00
3000	-151.00
5000	-156.00
