[Docket No. 2003-SW-23-AD; Amendment 39-13966; AD 2005-03-10]

Airworthiness Directives; Bell Helicopter Textron, A Division of Textron Canada Model 222, 222B, 222U and 230 Helicopters

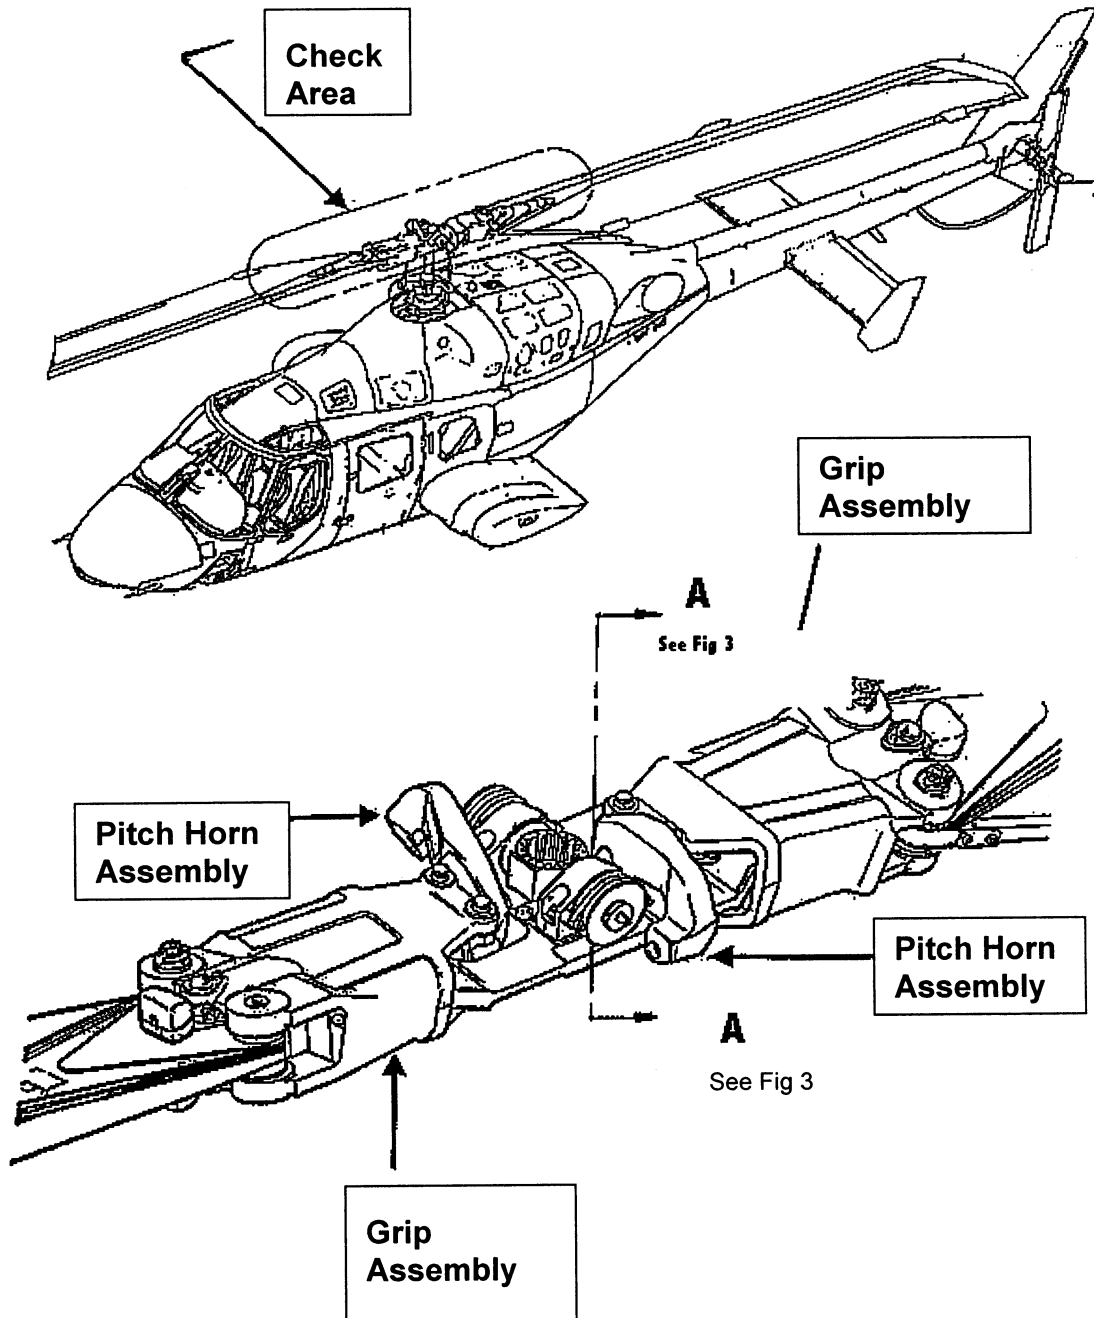
(1) Wipe clean the main rotor grip and pitch horn surfaces to remove grease and dirt in the check area as shown in Figure 1 of this AD:

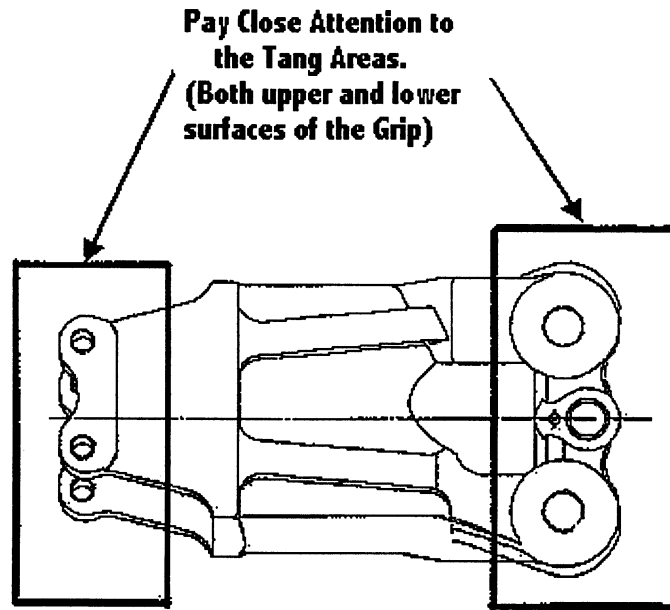
(2) Visually check both main rotor grips for a crack. Pay particular attention to the inboard and outboard tangs portions of the

grip, which are in direct contact with the pitch horns and the main rotor blades and check the area to at least 3 inches beyond the

grip to pitch and grip to blade contact areas as shown in Figure 2 of this AD:

Entire surface of the grip must be checked

(d) If a crack is found, replace the cracked part with an airworthy part before further flight.

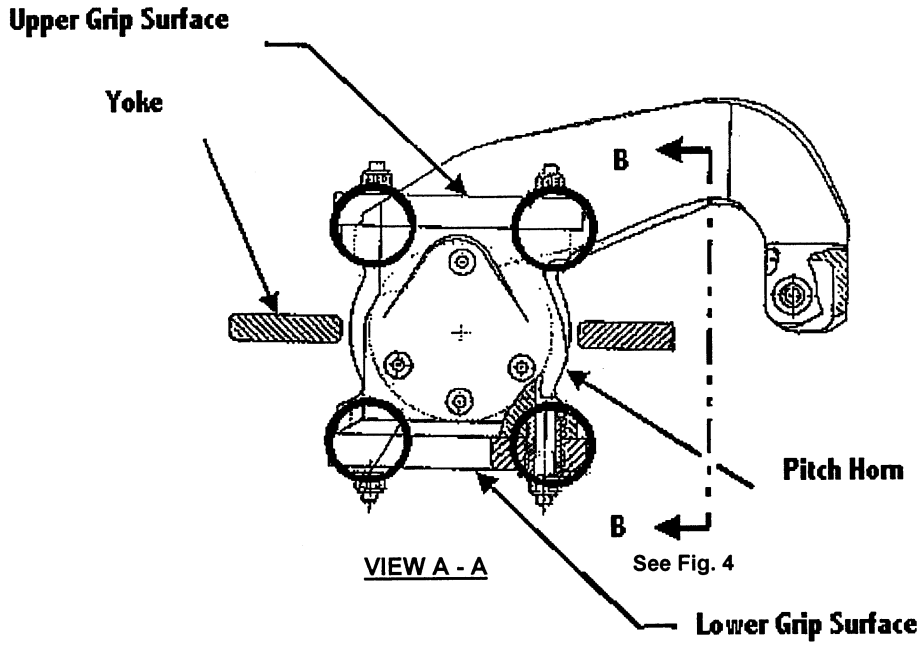
(3) Visually check all visible portions of each pitch horn for a crack. Pay particular attention to the attachment lugs of the pitch

horns, which are in direct contact with the inboard tangs of the main rotor grips, as shown in Figure 3 of this AD, and the four

**All visible portions of the pitch horn must be checked.
Pay particular attention to the circled areas shown above and View B-B, Fig. 4.**
