[Docket No. 2003–SW–10–AD]

Airworthiness Directives; Eurocopter France Model AS355E, F, F1, F2, and N Helicopters

ACTION: Notice of proposed rulemaking (NPRM).

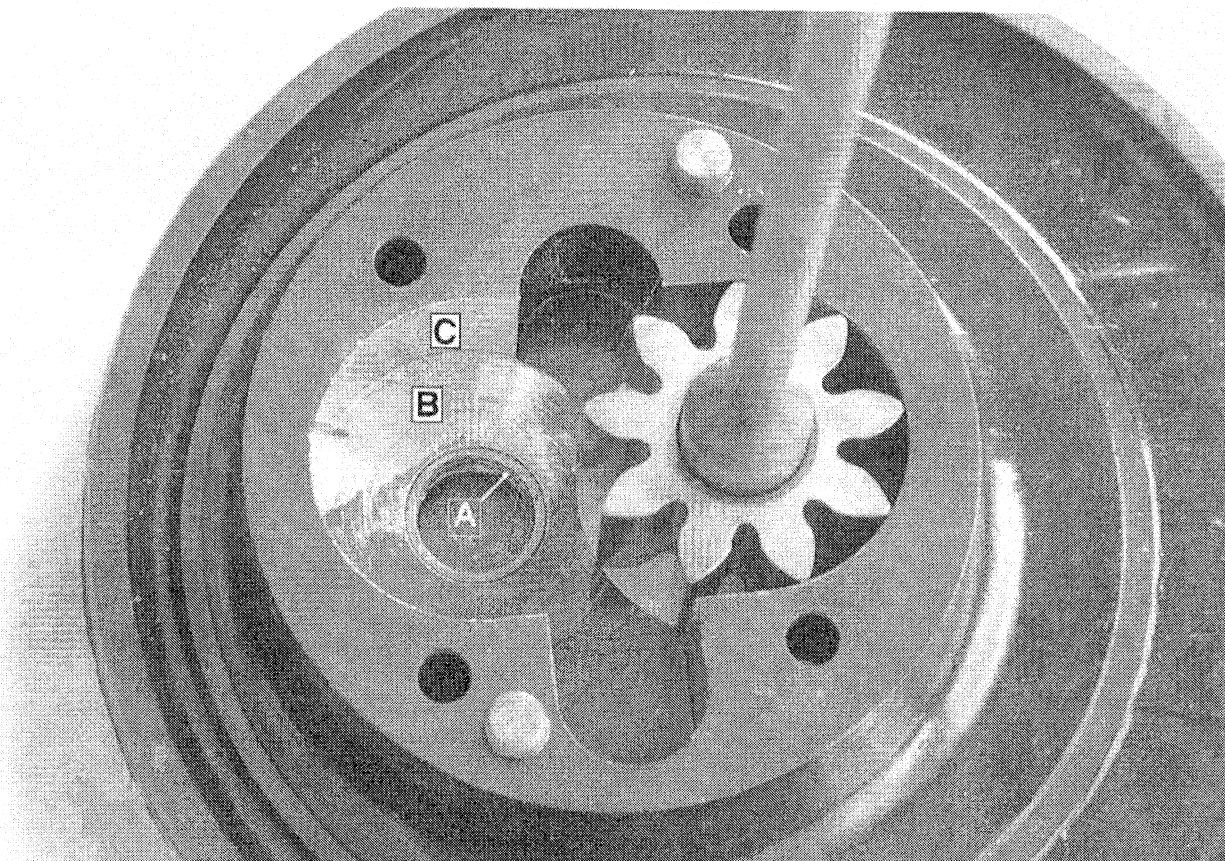
Figure 1

- (1) Crank pin play,
- (2) Out of round bronze bushing (A of Figure 1),
- (3) Offset of the driven gear pinion,
- (4) Metal chips, or
- (5) Wear (C of Figure 1).

Note 2: If wear is present in the B area only as depicted in Figure 1, replacing the MGB and the pump is not required.

(d) While inspecting the pump, if you find any of the following, replace the MGB and the pump with an airworthy MGB and pump before further flight:
