[FRA Emergency Order No. 24; Docket No. FRA-2005-22796, Notice No. 1]

Emergency Order Requiring Special Handling, Instruction and Testing of Railroad Operating Rules Pertaining to Hand-Operated Main Track Switches

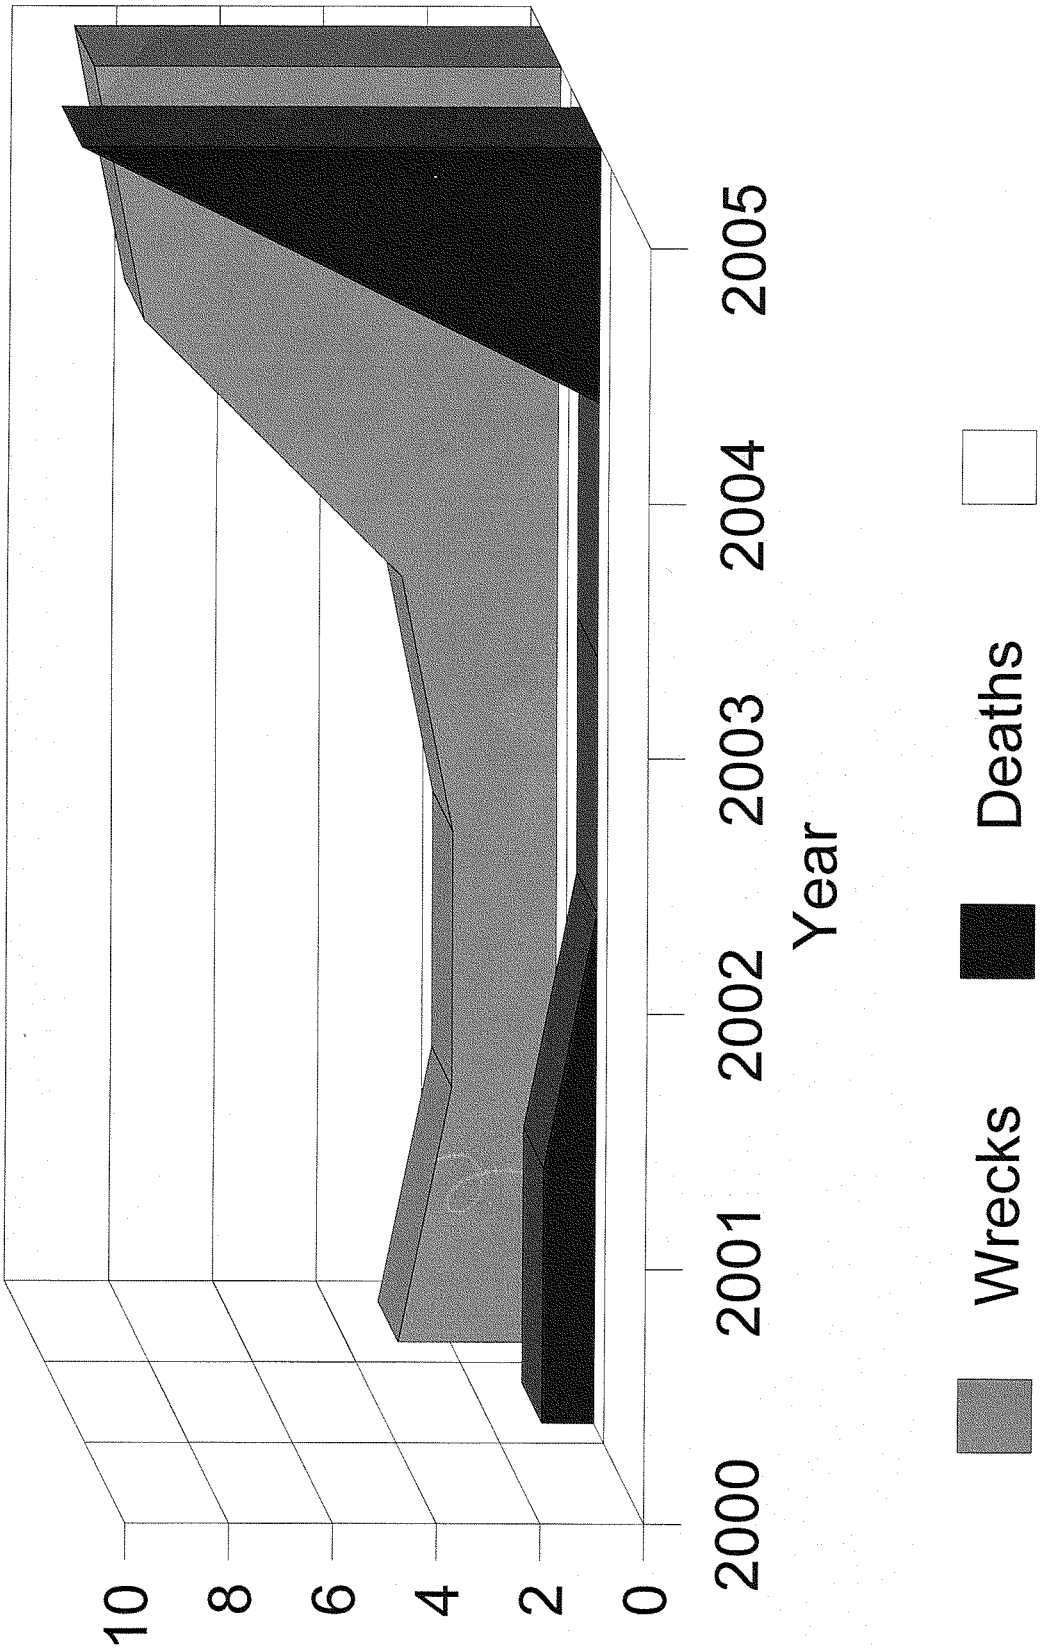
Wrecks & Deaths

In comparison, in 2004 there was a sharp increase in the frequency and severity of collisions resulting from improperly lined main track switches as shown on the attached charts. In 2004, there were a total of eight accidents resulting in eight injuries to railroad employees. The increase in the number of accidents and injuries did not go unnoticed by the industry as some railroads amended their operating rules to address this issue.

Finding and Order: Collisions, deaths and injuries resulting from improperly lined main track switches began in 2004 to rise very sharply as shown on the attached charts. FRA's issuance of a Safety Advisory in early January 2005, recommending practices designed to prevent such events, led to a nearly six month respite. The sharply rising and accelerating trend of collisions, deaths and injuries resulting from improperly lined main track switches, which the Safety Advisory abated only temporarily, constitutes an emergency situation involving a hazard of death or personal injury which FRA must act to stop.
