DEPARTMENT OF TRANSPORTATION

Federal Railroad Administration

Safety Advisory 2006-01

SUMMARY: FRA is issuing Safety Advisory 2006-01, in order to provide the industry additional information on the potential catastrophic failure of certain railroad freight car side frame castings manufactured by National Castings of Mexico's (NCM) Sahagun, Mexico facility and Buckeye Steel Castings' (Buckeye) Columbus, Ohio facility. The purpose of this safety advisory is to recommend that the rail industry carefully inspect these specific side frames when equipped freight cars are in shops or on repair tracks.

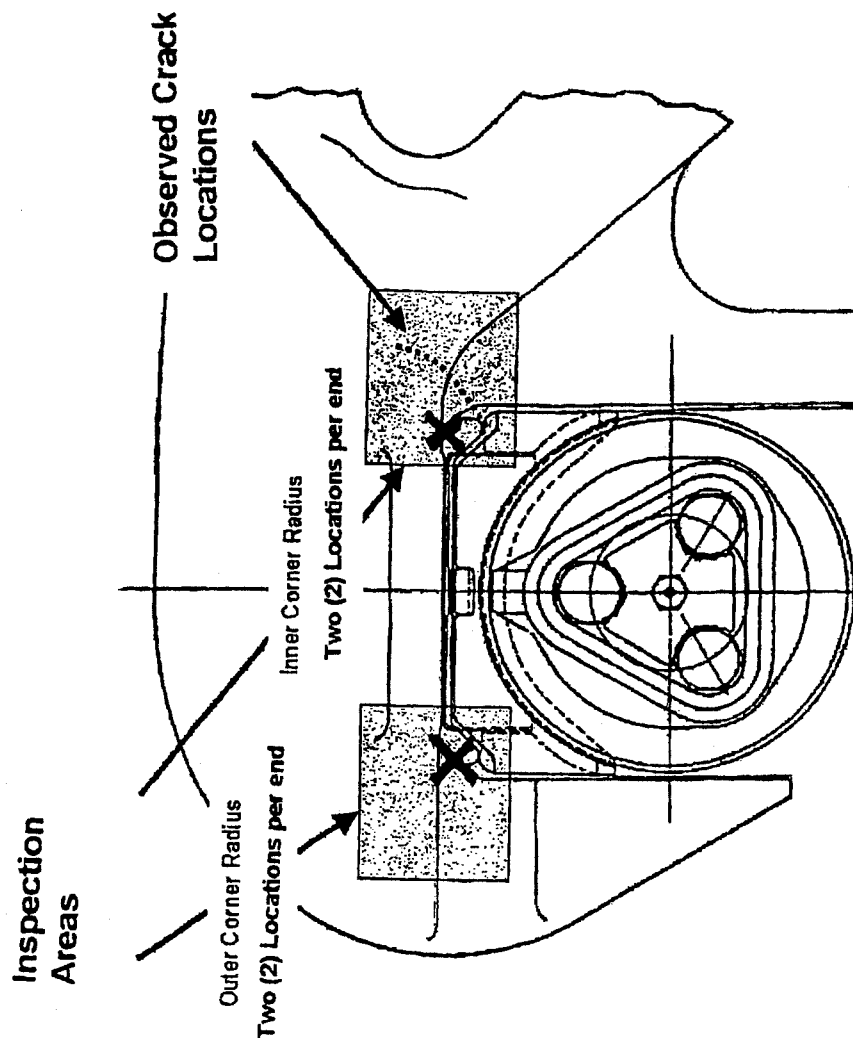
Fig. 1 Showing Eight Inspection Locations Per Side Frame

Preliminary information indicates that there are three pattern types produced by these manufacturers most susceptible to failure. Most of the side frames that have failed to date had received some

type of welded repair during the manufacturing process. In addition, preliminary analysis has in some cases indicated porosity and possible hardness problems with the involved

castings. The following table identifies the three pattern numbers of side frames manufactured by NCM and Buckeye that may have the potential to fail while in-service.

Recommended Action: In recognition of the need to assure safety, FRA recommends that railroads carefully inspect the side frames identified in this advisory when any freight car equipped with the involved side frames is on a

shop or repair track. Railroad freight cars equipped with side frames in these pattern numbers should receive a careful inspection of the side frames at the inner corner radius (spring nest and outboard sides) of the pedestal jaw opening (field or gage side) at the transition from the pedestal roof. There are eight (8) locations per side frame that should receive close visual inspection. (See Figure 1). Any evidence of cracking and/or missing material in the corner radius areas is cause for replacement.
