Special Conditions: Boeing Model 747-8/-8F Airplanes; Additional Airframe Structural Design Requirements Related to Sudden Engine Stoppage Due to Fan Blade Failures

[Docket No. FAA-2009-0464; Directorate Identifier 2008-NM-189-AD; Amendment 39-15992; AD 2008-16-09 R1]

Airworthiness Directives; Short Brothers Model SD3-60 Airplanes

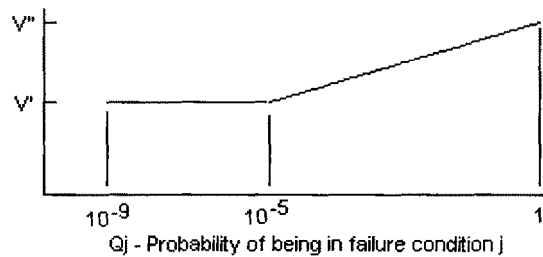
Clearance speed

V' = Clearance speed as defined by § 25.629(b)(2).

V'' = Clearance speed as defined by § 25.629(b)(1).

$Q_j = (T_j)(P_j)$ where:

T_j = Average time spent in failure condition j (in hours)

P_j = Probability of occurrence of failure mode j (per hour)

Note: If P_j is greater than 10^{-3} per flight hour, then the flutter clearance speed must not be less than V''.

(6) Freedom from aeroelastic instability must also be shown up to V' in Figure 3 above, for any probable system failure condition combined with any damage required or selected for investigation by § 25.571(b).
