[Docket No. FAA-2010-0342; Directorate Identifier 2002-NE-08-AD; Amendment 39-16458; AD 2010-20-23]

Airworthiness Directives; Bombardier-Rotax GmbH Type 912 F, 912 S, and 914 F Series Reciprocating Engines

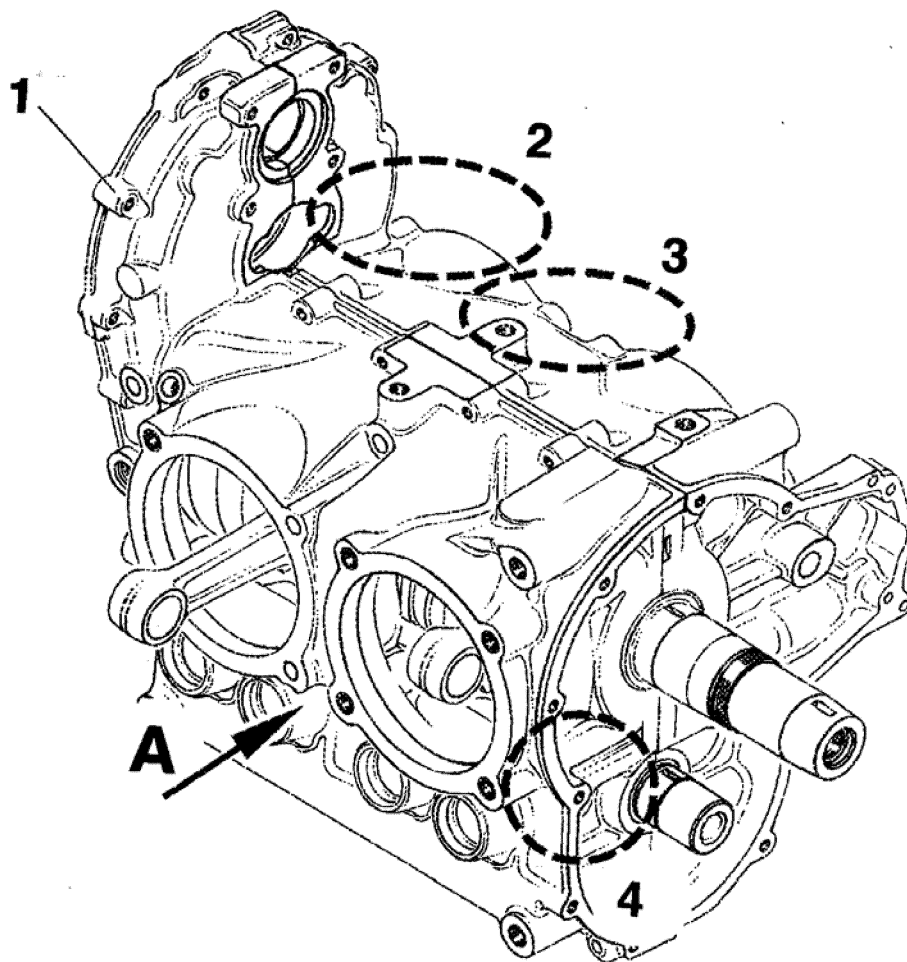
Figure 1. Engine Crankcase Inspection Areas

- (1) Inspect the engine crankcase (item 1, Figure 1 of this AD) for cracks especially in the area of cylinder 1 upper side (item 2), between cylinder 1 and 3 upper side (item 3), cylinder 4 lower-right side (item 4) and detailed inspection in the area identified in Figure 2 (item 5) of this AD. Information concerning this inspection can be found in Bombardier-Rotax Mandatory Service Bulletins No. SB–912–029, Revision 3, dated July 11, 2006 and No. SB–914–018, Revision 3, dated July 11, 2006.

(2) Cracks in crankcases of engines with a ROTAX cooling air baffle may not be easily visible, and oil leaks may be an indication of cracks. Visually inspect for oil leaks in areas of cylinder 1 upper side (item 2, Figure 1 of this AD) and between cylinder 1 and cylinder 3 upper side (item 3).

(4) If the engine crankcase is cracked, remove the engine from service before further flight.

(h) Visually inspect the engine crankcase (item 1, Figure 1 of this AD) for cracks at each 100-hour, annual, or progressive inspection, or within 110 hours TIS since last inspection, whichever occurs first, in accordance with paragraphs (g)(1) through (g)(4) of this AD.

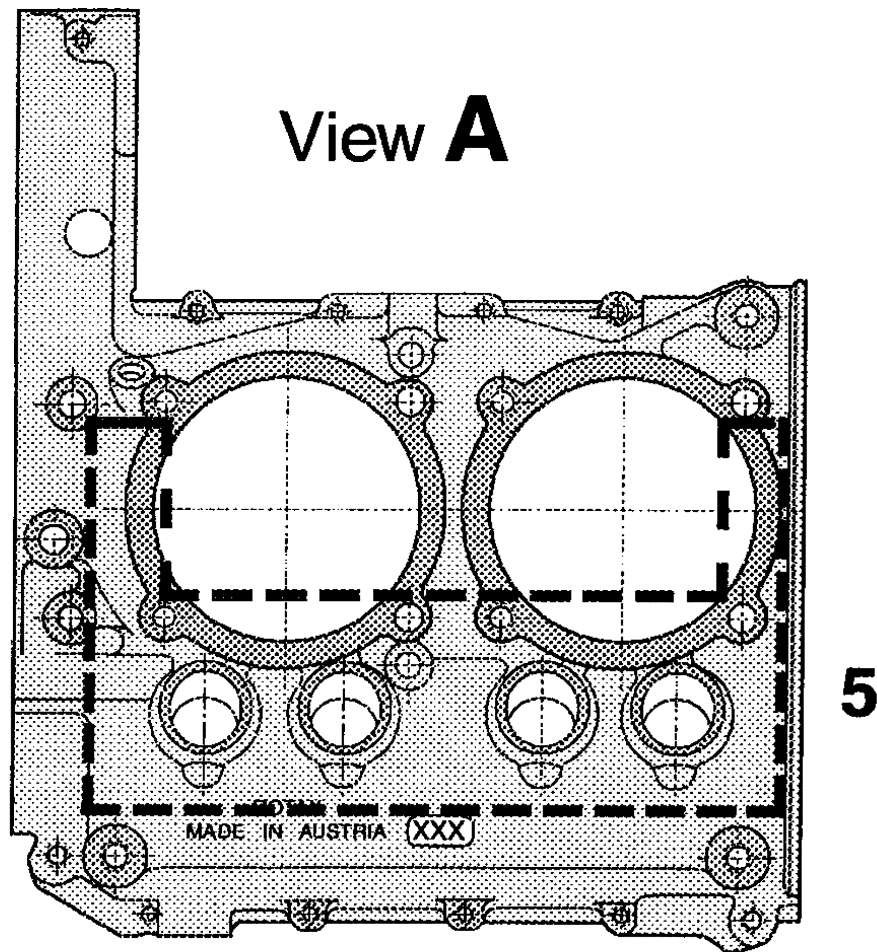
Figure 2. Engine Crankcase Inspection Areas – View A

(f) Determine if your crankcase is affected by looking at the S/N in the area indicated by XXX, following "Made in Austria," as shown on Figure 2 of this AD. The marking is on both crankcase halves.

(k) Installing a crankcase that has a S/N above 27811 terminates the inspection requirements of paragraphs (g)(1) through (g)(4) and (h) of this AD.
