[Docket No. FAA-2010-1270; Directorate Identifier 2001-NE-50-AD; Amendment 39-16788; AD 2005-25-10R1]

Airworthiness Directives; Dowty Propellers Type R321/4-82-F/8, R324/4-82-F/9, R333/4-82-F/12, and R334/4-82-F/13 Propeller Assemblies

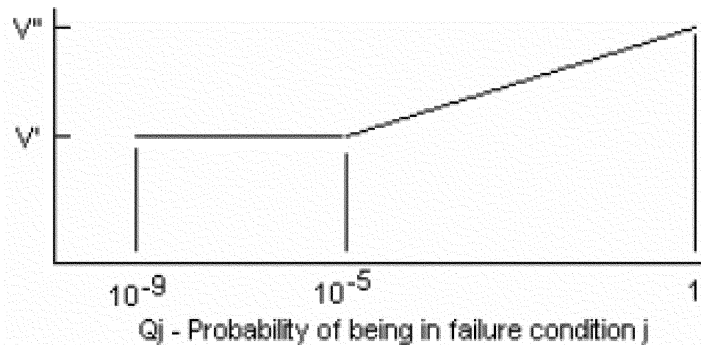
Figure 3. Clearance speed

V' = Clearance speed as defined by Sec. 25.629(b)(2).

V'' = Clearance speed as defined by Sec. 25.629(b)(1).

Note: If P_j is greater than 10^{-3} per flight hour, then the flutter clearance speed must not be less than V'' .

(v) Freedom from aeroelastic instability must also be shown up to V' in Figure 3, above, for any probable system-failure condition combined with any damage required or selected for investigation by § 25.571(b). Consideration of certain failure conditions may be required by other sections of part 25 regardless of calculated system reliability. Where analysis shows the probability of these failure conditions to be less than 10^{-9} , criteria other than those specified in this paragraph may be used for structural substantiation to show continued safe flight and landing.
