**DEPARTMENT OF TRANSPORTATION****Federal Aviation Administration****14 CFR Part 39**

**[Docket No. FAA–2009–1088; Directorate Identifier 2008–SW–76–AD]**

**Airworthiness Directives; Sikorsky Aircraft Corporation Helicopters**

**ACTION:** Supplemental notice of proposed rulemaking (NPRM); reopening of comment period.

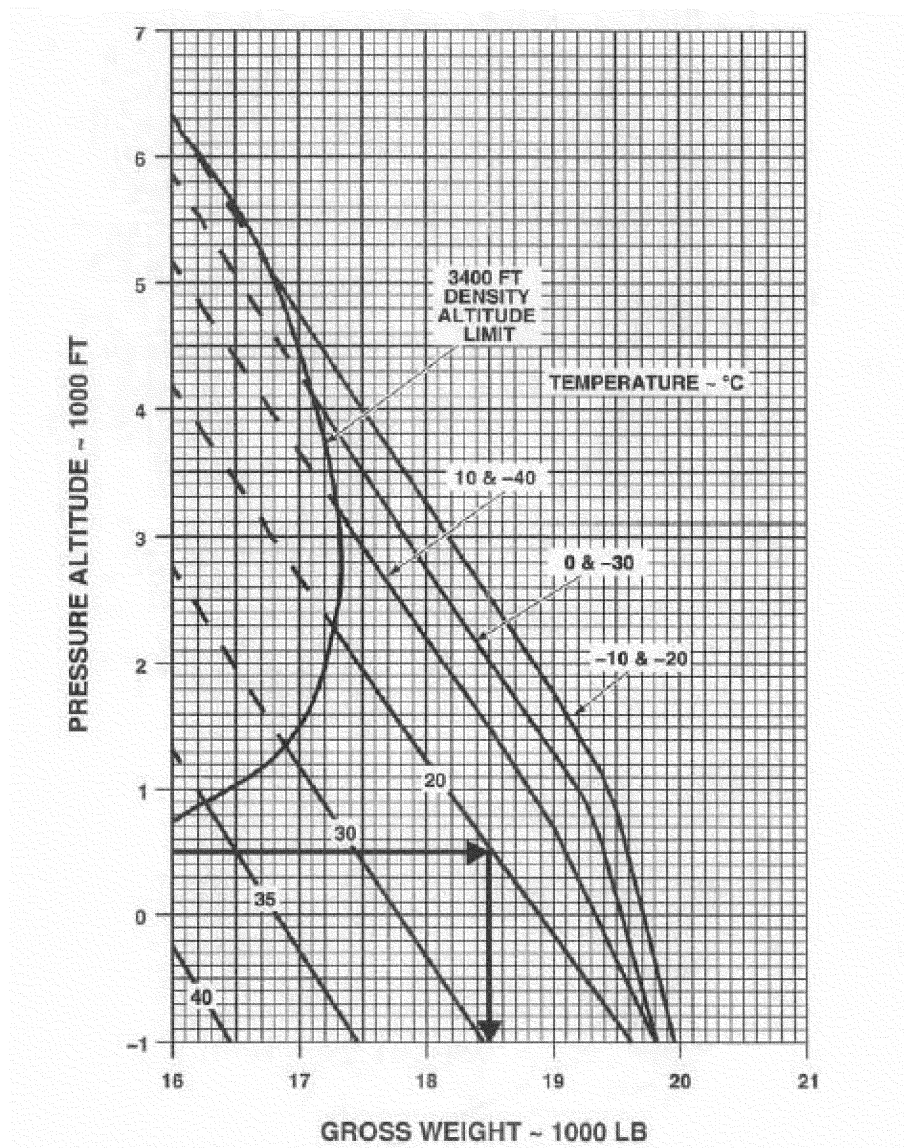
**Figure 1-2A to Paragraph (d), Maximum Gross Weight for HEC Requiring Cat 'A'**

**NOTE 1 to Figure 1-2A to Paragraph (d) of this AD: THIS CHART DEPICTS THE GROSS WEIGHT, PRESSURE ALTITUDE, TEMPERATURE COMBINATION WHERE OEI HOGE CAPABILITY EXISTS USING 30 SECOND OEI POWER WITH A 60 SHP MARGIN.**

**NOTE 2 to Figure 1-2A to Paragraph (d) of this AD: 15 FT OF GROUND CLEARANCE IS ASSURED IN THE EVENT OF AN ENGINE FAILURE AT 20 TO 80 FT AGL.**

(ii) Add this paragraph and figure: “HOIST Maximum gross weight for Human External Cargo, which requires category ‘A’

performance capabilities, is limited to the gross weight determined in accordance with the following Figure 1–2A to Paragraph (d) of this AD for your altitude and temperature with the air-conditioner, anti-ice, and bleed air turned off.”
