[Docket No. FAA-2016-0733; Directorate Identifier 2015-SW-040-AD]

Airworthiness Directives; Robinson Helicopter Company Helicopters

ACTION: Notice of proposed rulemaking (NPRM).

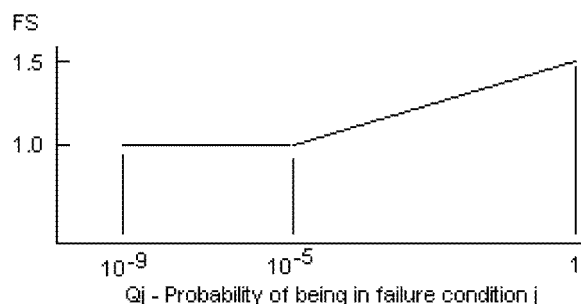
Figure 2: Factor of safety for continuation of flight

$$Q_j = (T_j)(P_j)$$

Where:

T_j = Average time spent in failure condition j (in hours)

P_j = Probability of occurrence of failure mode j (per hour)

Note: If P_j is greater than 10^{-3} per flight hour, then a 1.5 factor of safety must be applied to all limit load conditions specified in Subpart C.
