#### 14 CFR Part 39

[Docket No. FAA-2017-0288; Directorate Identifier 2017-CE-007-AD]

#### Airworthiness Directives; Textron Aviation Inc. Airplanes

**SUMMARY:** We propose to adopt a new airworthiness directive (AD) for all Textron Aviation Inc. Models A36TC and B36TC airplanes. This proposed AD was prompted by a fatal accident where the exhaust tailpipe fell off during takeoff. This proposed AD would add a life limit to the exhaust tailpipe v-band coupling (clamp) that attaches the

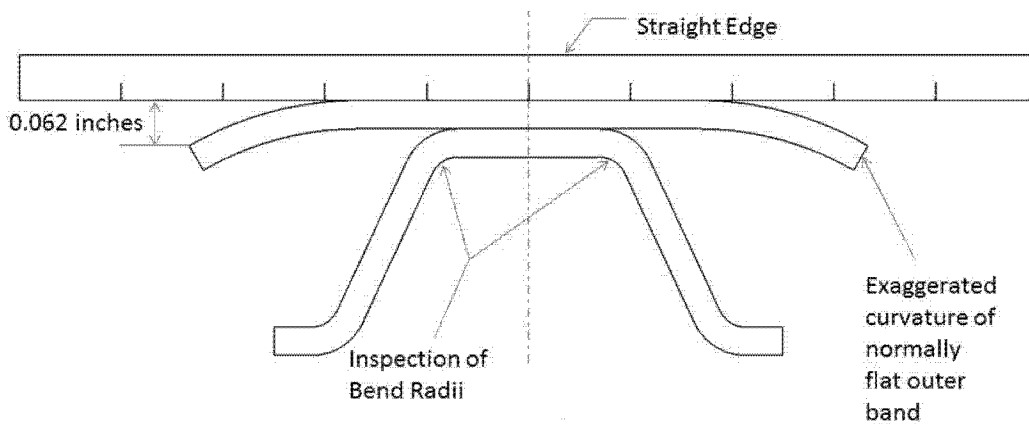
Figure 1 to paragraphs (h)(1)(iii) and (v) of this AD: Cross section of v-band coupling

(iii) Visually inspect the flatness of the outer band using a straight edge. Lay the straight edge across the width of the outer band. The gap must be less than 0.062 inches. See figure 1 to paragraphs (h)(1)(iii) and (v) of this AD. If the gap exceeds 0.062 inches between the outer band and the straight edge, do not re-install the v-band coupling. Before further flight, you must install a new v-band coupling and restart the hours TIS for the repetitive replacement of the v-band coupling.

(v) Visually inspect the bend radii of the coupling v-retainer coupling segments for cracks. Inspect the radii throughout the length of the segment. See figure 1 to paragraphs (h)(1)(iii) and (v) of this AD. If any cracks are found, do not re-install the v-band coupling. Before further flight, you must install a new v-band coupling and restart the hours TIS for the repetitive replacement of the v-band coupling.
