[Docket No. FAA-2018-0454; Product Identifier 2017-NM-056-AD; Amendment 39-19387; AD 2018-18-08]

Airworthiness Directives; Airbus SAS Airplanes

ACTION: Final rule.

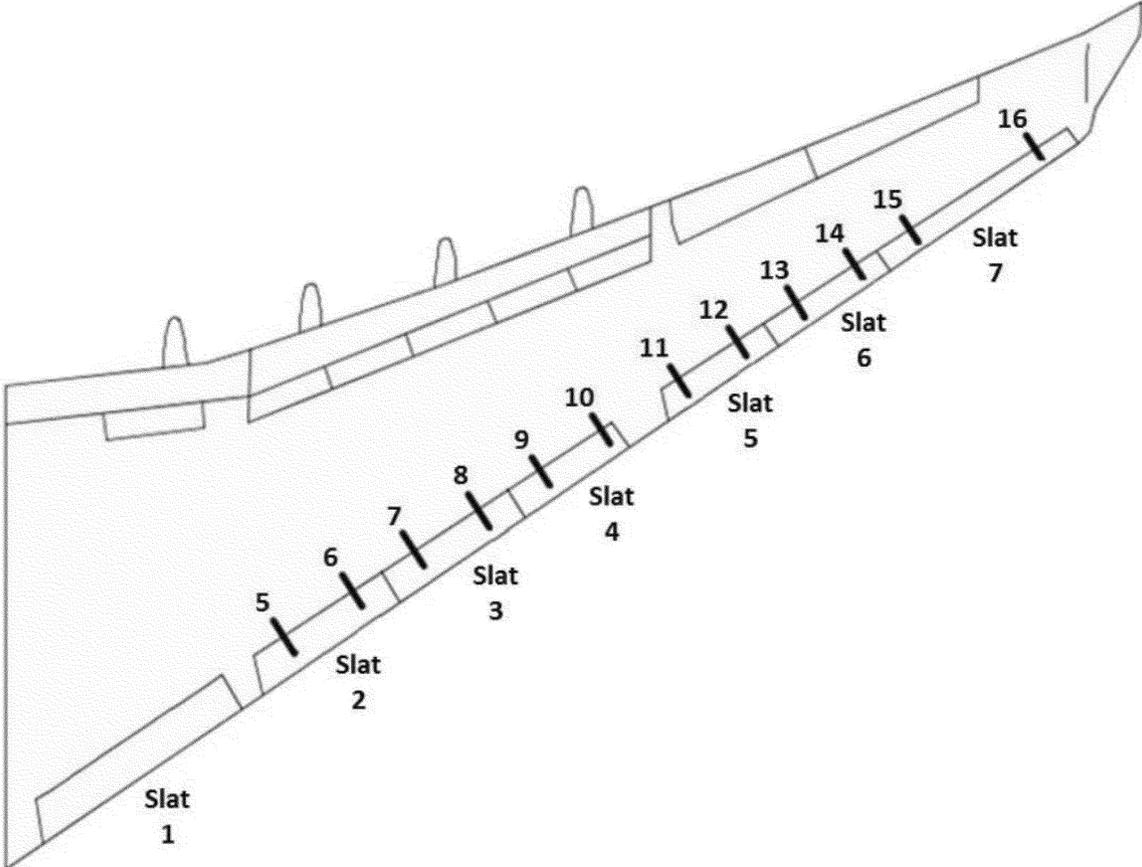
Figure 1 to paragraph (g) of this AD – Positions of Affected Slat Tracks

This AD was prompted by reports of cracked slat tracks at the location of the front stop attachment to the track. We are issuing this AD to detect and correct cracked slat tracks which could affect the structural integrity of the slat surface, possibly leading to detachment of an outer or inner slat surface, and resulting in reduced control of the airplane.

(1) For the purpose of this AD, "affected slat track" is defined as a pre-modification 45967 slat track, located at the wing positions as indicated in figure 1 to paragraph (g) of this AD, and having a part number specified in figure 2 to paragraph (g) of this AD. In case the part number identification (ID) plate is missing or cannot be read, the slat track can be identified by the ink marking. If the operator cannot determine the part number, then that airplane is in Group 1.

For Group 1 airplanes: At the applicable times specified in figure 3 to paragraph (h) of this AD, do a detailed inspection of the front stop lateral and aft surfaces, and do a special detailed inspection of the front stop
