[Docket No. FAA–2018–0479; Product Identifier 2016–NE–23–AD; Amendment 39–19369; AD 2018–17–15]

Airworthiness Directives; Honeywell International Inc. Turboprop and Turboshaft Engines

Airworthiness Directives; Airbus Defense and Space S.A. (Formerly Known as Construcciones Aeronauticas, S.A. (CASA)) Airplanes

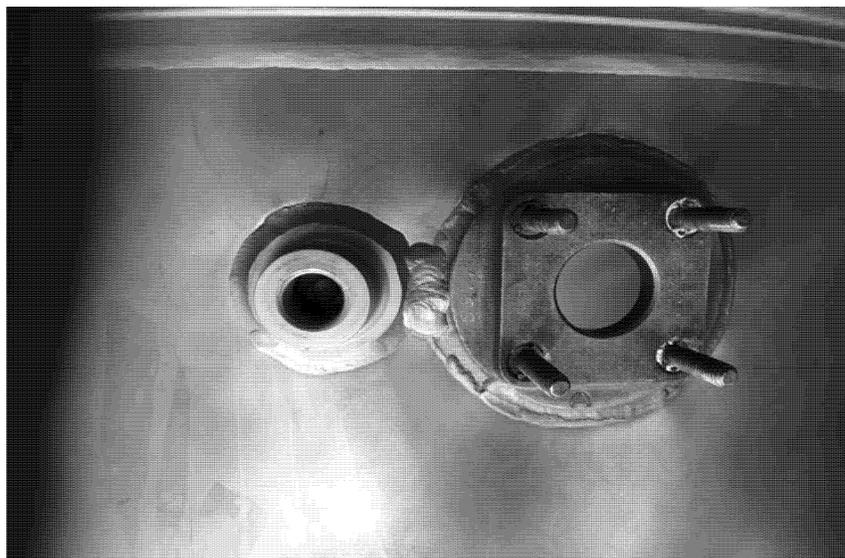
Figure 1 to Paragraph (h) of this AD. Combustion Chamber Case Assembly Without the One-Piece Bleed Pad with P3 Boss

(2) Figures 1 and 2 to paragraph (h) of this AD illustrate the appearance of combustion chamber case assembly, P/N 893973–5, without and with, respectively, the one-piece bleed pad with the P3 boss.

After the effective date of this AD, do not install a combustion chamber case assembly, P/N 869728-1, 869728-3, or 893973-5, in TPE331-3U, -3UW, -5, -5A, -5AB, -5B, -6, and -6A engine models or in TPE331-1, -2, and -2UA engine models modified by National Flight Services, Inc., STC SE383CH, unless the combustion chamber case assembly has a one-piece bleed pad with P3 boss.
