DEPARTMENT OF TRANSPORTATION

National Highway Traffic Safety Administration

Denial of Motor Vehicle Defect Petition, DP13–001

ACTION: Denial of petition for a defect investigation.

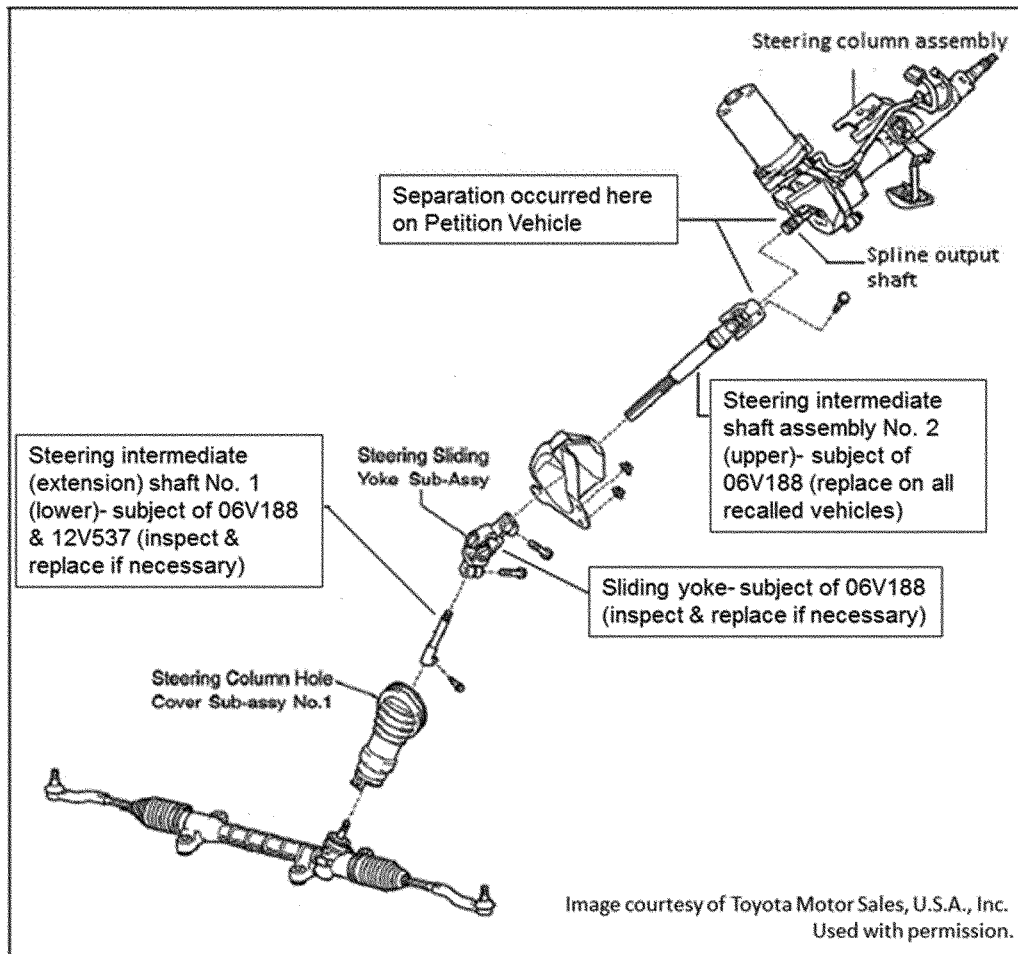
The subject power steering system is assisted by an electric motor linked to the steering column assembly. Steering torque is transmitted to a manual steering rack via a pair of intermediate shafts and a sliding yoke assembly. Image 1 below illustrates the Toyota Prius steering system and the components subjected to the two recalls.
