[Docket No. FAA-2020-0883; Project Identifier 2019-CE-034-AD]

## Airworthiness Directives; Rockwell Collins, Inc. Flight Display System Application

**AGENCY:** Federal Aviation Administration (FAA), DOT. **ACTION:** Notice of proposed rulemaking (NPRM). SUMMARY: The FAA proposes to supersede Airworthiness Directive (AD) AD 2019–12–09, which applies to certain Rockwell Collins, Inc. (Rockwell Collins) FDSA-6500 flight display system applications installed on airplanes. AD 2019-12-09 imposes operating limitations on the traffic collision avoidance system (TCAS). AD 2019–12–09 was prompted by conflict between the TCAS display indications and aural alerts that may occur during a resolution advisory (RA) scenario. This proposed AD would retain the requirements of AD 2019-12-09 until a software upgrade is completed. The FAA is proposing this AD to address the unsafe condition on these products. **DATES:** The FAA must receive comments on this proposed AD by January 28, 2021.

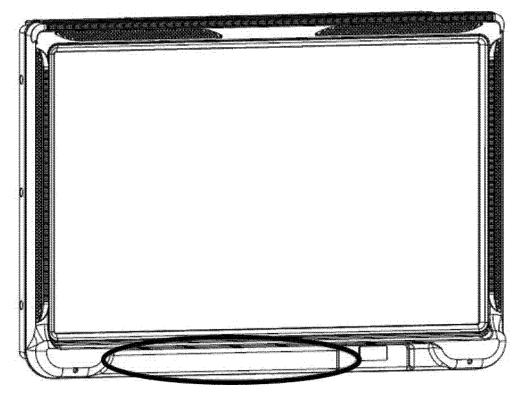
Figure 1 to paragraph (g)(1)(iii); placard location on bezel

(ii) Fabricate a placard for each aircraft primary flight display, using at least ¼ inch letters, with the following text: TCAS Flight Ops—TA Only mode (TA/RA mode prohibited).

(iii) Install the placard on the bottom of each aircraft primary flight display bezel in the area depicted in figure 1 to paragraph (g)(1)(iii) of this AD.
