[Docket No. FAA–2023–1814; Project Identifier AD–2023–00773–T; Amendment 39–22541; AD 2023–17–14]

#### Airworthiness Directives; The Boeing Company Airplanes

**2023-17-14 The Boeing Company:**  
Amendment 39-22541; Docket No. FAA-2023-1814; Project Identifier AD-2023-00773-T.

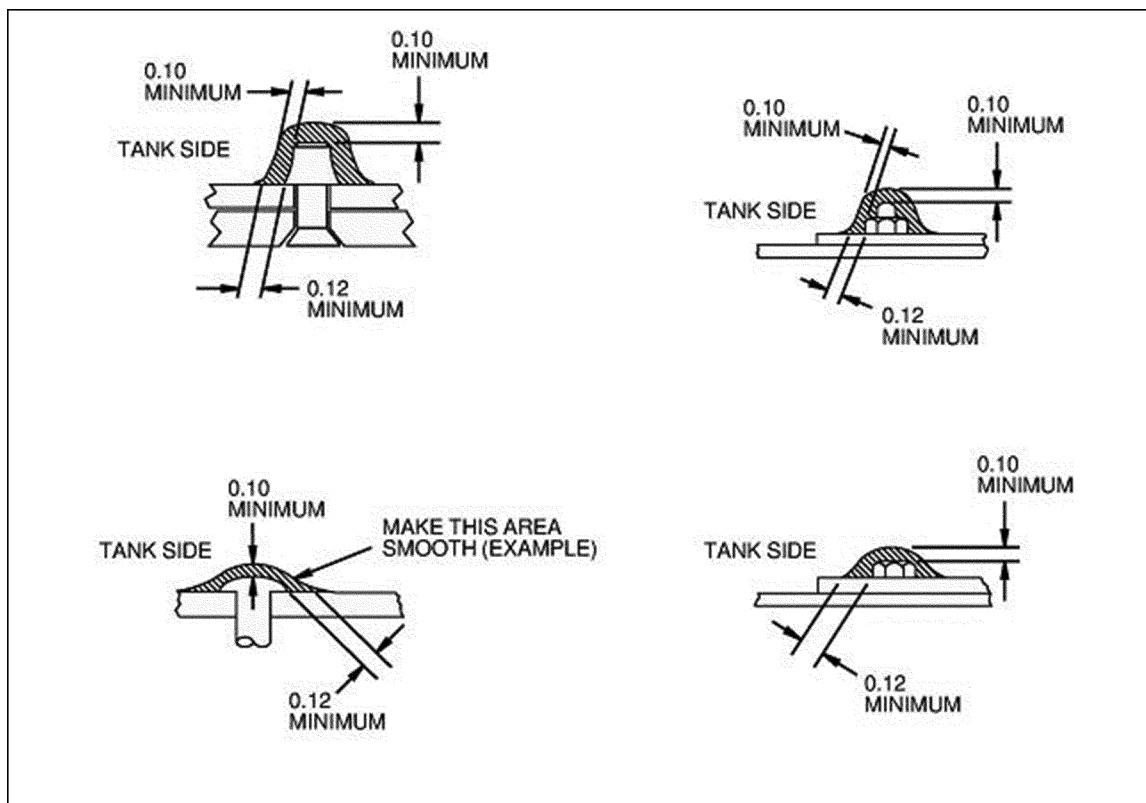
**Figure 1 to paragraph (h)(4)—Cap seal minimum thickness (all dimensions in inches)**

This AD was prompted by a report of a crack found in a front spar lower chord undergoing an underwing longeron replacement, and the determination that AD 2022-18-11 did not specify the appropriate thickness for the application of cap seals to fasteners penetrating the center wing fuel tank. The FAA is issuing this AD to detect and correct such cracking, which in combination with cracking in the front spar web, could result in a fuel leak and fire hazard. In addition, cap seals applied below the necessary thickness may fail to contain a

spark resulting from a lightning strike, possibly resulting in a fuel tank explosion.

(4) During application of any cap seal to a fastener, fastener head, and fastener threads and collars, as required by this AD, the cap seal must be applied with a thickness equal to or greater than the dimensions specified in figure 1 to paragraph (h)(4) of this AD.

(2) If any cap seal was applied using procedures with thickness dimensions less than those given in figure 1 to paragraph (h)(4) of this AD, or if the maintenance records do not definitively specify the procedures used: At the applicable time specified in paragraph (i)(2)(i) or (ii) of this AD, replace the cap seal in accordance with the Accomplishment Instructions of Boeing Alert Requirements Bulletin 777-57A0122 RB, dated October 8, 2021, using a cap sealing procedure with thickness greater than or equal to the dimensions given in figure 1 to paragraph (h)(4) of this AD.

(3) For any cap seal that was not applied, or for any cap seal that was removed for inspections and not replaced, or if the maintenance records do not definitively specify the procedures used: At the applicable time specified in paragraph (i)(3)(i) or (ii) of this AD, apply a cap seal of BMS 5-45 sealant using an accepted method with thickness greater than or equal to the dimensions given in figure 1 to paragraph (h)(4) of this AD.
