[Docket No. FAA-2024-2011; Project Identifier AD-2023-01121-R; Amendment 39-22885; AD 2024-23-06]

Airworthiness Directives; MD Helicopters, LLC, Helicopters

2024–23–06 MD Helicopters, LLC: Amendment 39–22885; Docket No. FAA–2024–2011; Project Identifier AD–2023–01121–R.

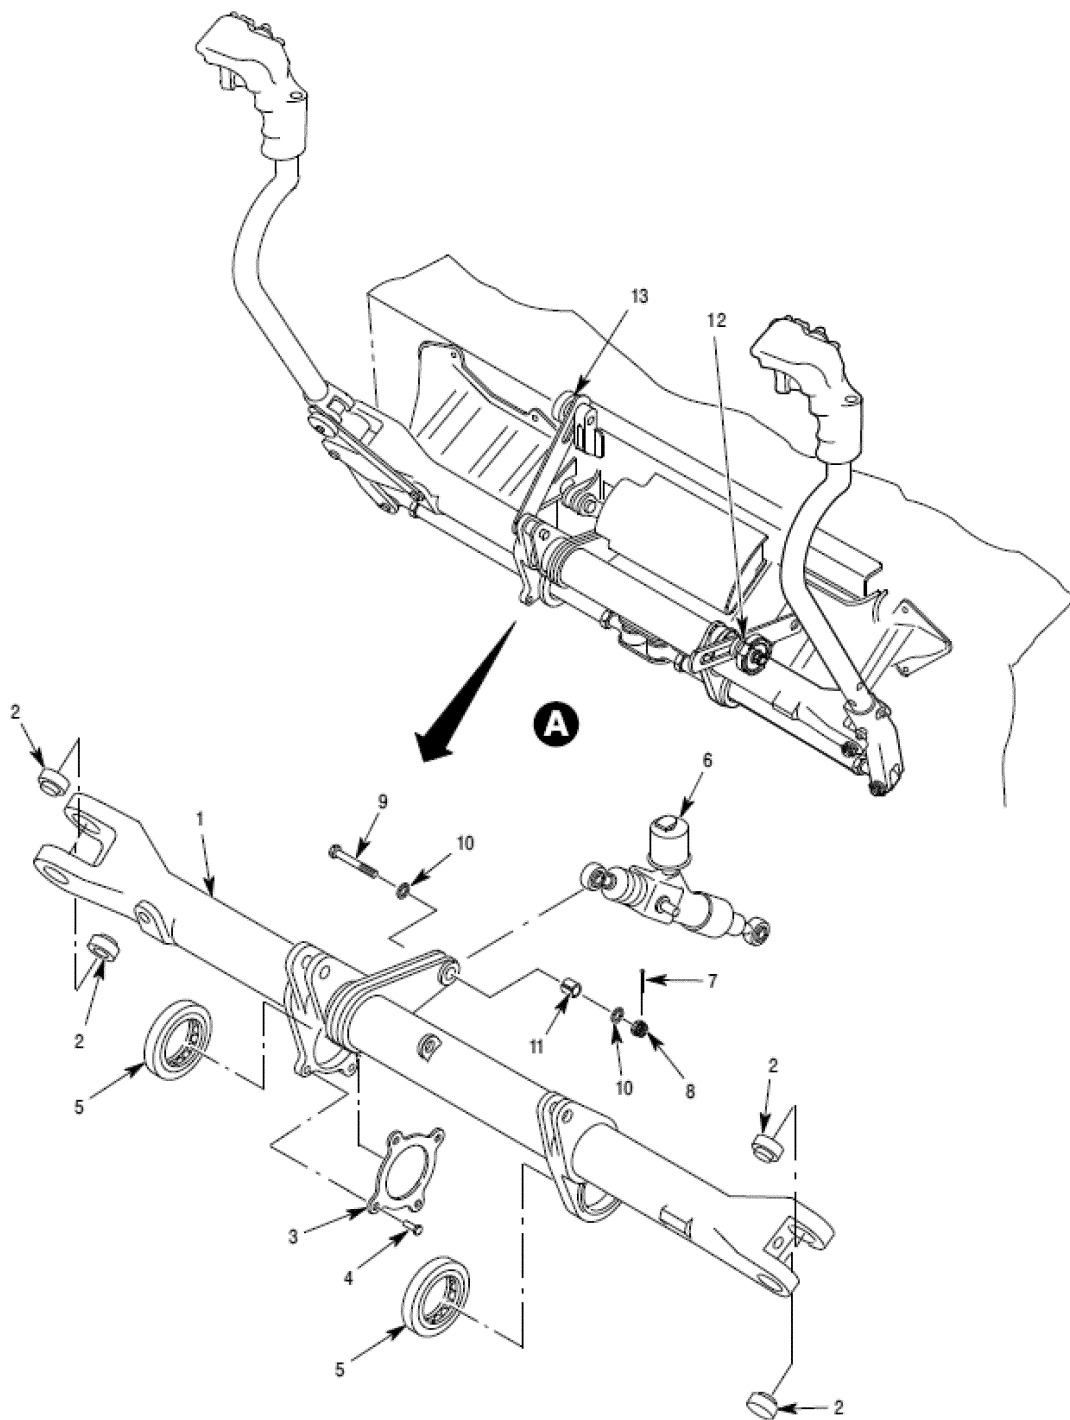
Figure 1 to Paragraph (g)(1)—Torque Tube Assembly

This AD was prompted by a report of a seized and damaged roller bearing in the torque tube assembly. The FAA is issuing this AD to prevent failure of the torque tube assembly. The unsafe condition, if not addressed, could result in reduced controllability and subsequent loss of control of the helicopter.

(ii) Visually inspect each roller bearing (number 5) as depicted in Figure 1 to paragraph (g)(1) of this AD for corrosion and degradation. If a roller bearing has any corrosion or degradation, before further flight, remove the roller bearing from service and install an airworthy roller bearing.

this AD, before further flight, inspect each roller bearing (number 5) as depicted in Figure 1 to paragraph (g)(1) of this AD for damage. For the purposes of this inspection, damage may be indicated by corrosion, lack of lubrication (dry exterior surface), or material degradation.

(i) Using a flashlight and mirror, visually inspect the torque tube for corrosion and cracks. If there is any corrosion or a crack, before further flight, remove the torque tube from service and install an airworthy torque tube.

(B) If any roller bearing (number 5) as depicted in Figure 1 to paragraph (g)(1) of this AD has any damage, before further flight, remove the roller bearing from service and install an airworthy roller bearing.

(B) Ensure the edge of the slotted bushing (number 11) protrudes 0.010 to 0.080 inch (0.25 to 2.03 mm) above the surface of the cyclic torque tube after the nut is tightened.
