DEPARTMENT OF TRANSPORTATION

Federal Railroad Administration

Safety Advisory 2023-05; King Pin Assemblies in Highway-Rail Grade Crossing Warning Systems

ACTION: Notice of safety advisory.

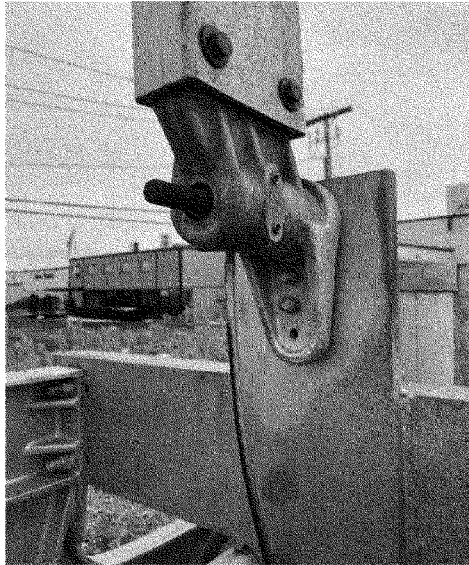
Figure 1-King pin and gate assembly

However, the king pin assembly can be damaged under normal operating conditions by vehicle strikes, high winds, rust, worn gate boot(s), and corrosion. If the highway-rail grade crossing gate is being held in place by a worn or damaged king pin assembly, the crossing gate may drop off the king pin and post pin tabs. When this occurs, the crossing gate may be held in place by only the shear bolts, which are not designed to hold the weight of the crossing gate. Therefore, if relied upon to hold the crossing gate in place, the shear bolts could stretch and break unexpectedly, allowing the crossing gate to fall. This could happen very quickly, potentially causing injury to railroad employees or members of the general public in close proximity to the crossing gate.

(1) Inspect king pin assemblies in highway-rail grade crossing warning systems and replace all worn components.
