Service Bulletin (SB) No. CF6–80C2 S/B 78–1068, Revision 2, dated May 16, 2005, any earlier revision, or original issue, or SB No. CF6–80C2 S/B 78–1077, Revision 1, dated May 16, 2005, or original issue; and

Unsafe Condition

Modifying the Latching System of the Fan Reverser

ST. LOUIS, MO CLASS B AIRSPACE AREA

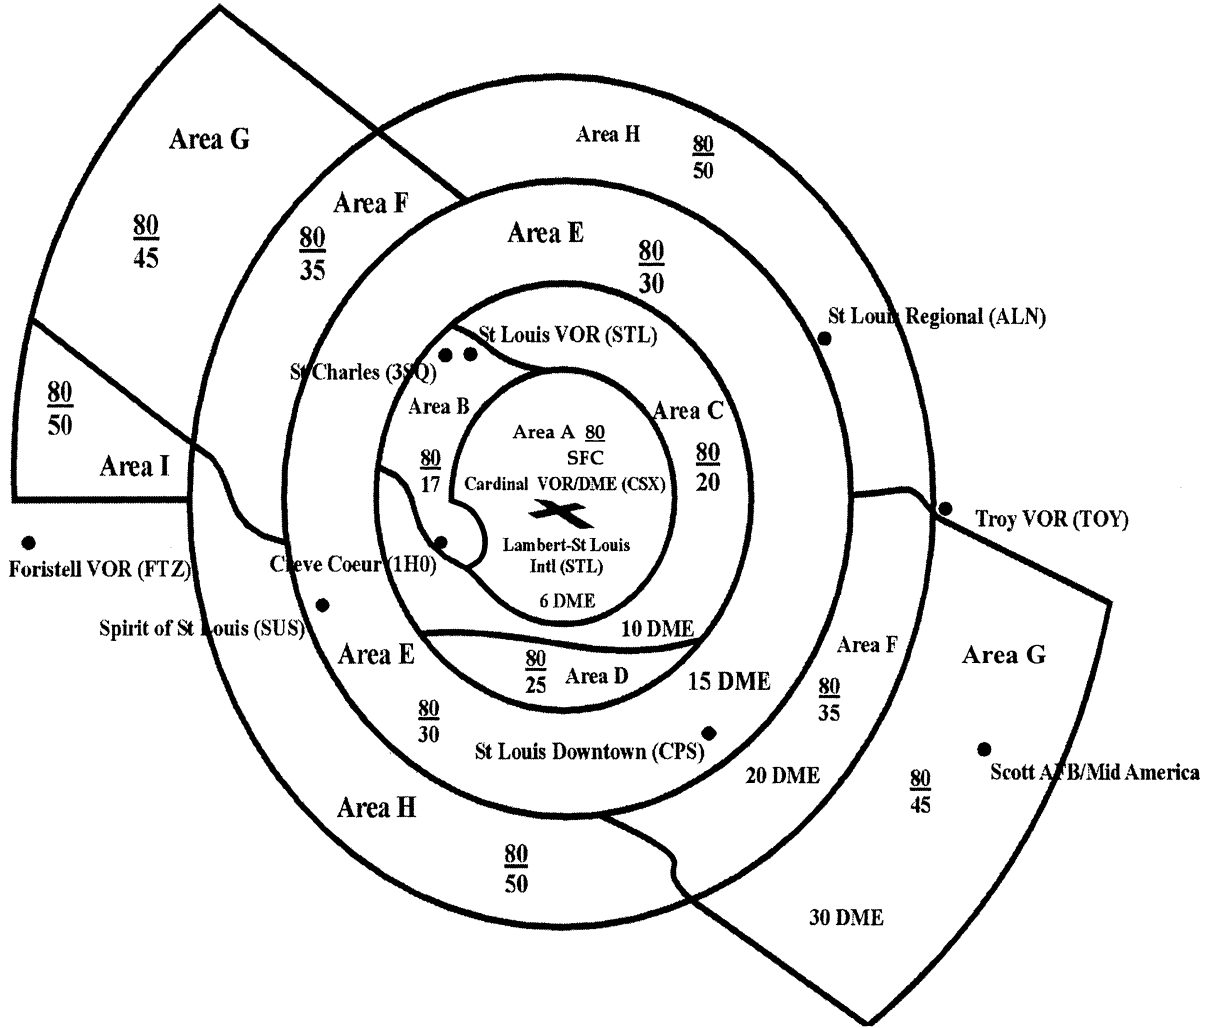
NOT TO BE USED FOR NAVIGATION

including 8,000 feet MSL (80/SFC). Also, the 1.5 NM radius exclusion around Creve Coeur Airport was not depicted. This action replaces the graphic reflecting the correct altitudes for area A and the exclusion around the Creve Coeur Airport.
