**DEPARTMENT OF TRANSPORTATION**

**Federal Aviation Administration**

**Airworthiness Directives; EADS CASA (Type Certificate Previously Held by Construcciones Aeronauticas, S.A.) Model CN-235, CN-235-100, CN-235-200, and CN-235-300 Airplanes, and Model C-295 Airplanes**

**ACTION:** Notice of Proposed Rulemaking (NPRM).

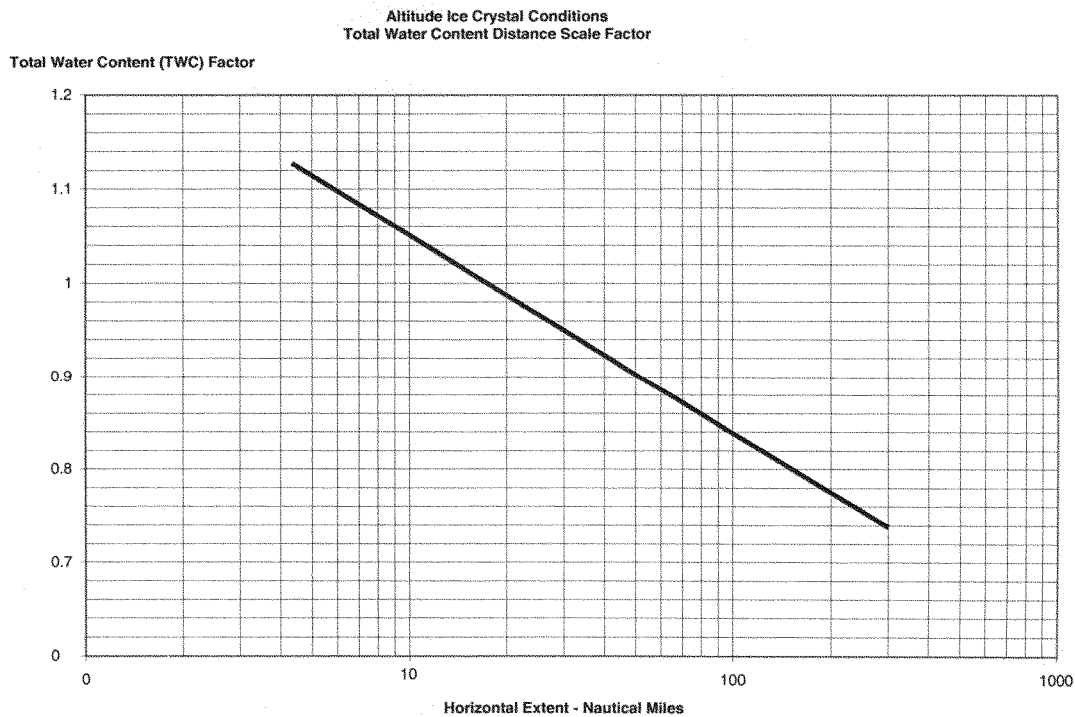
FIGURE D3 Exposure Length Influence on TWC

The TWC levels displayed in Figure D2 represent TWC values for a standard exposure distance (horizontal cloud length)

of 17.4 nautical miles that must be adjusted with length of icing exposure. The assessment from data measurements in

Reference 1 supports the reduction factor with exposure length shown in Figure D3.
