Airworthiness Directives; Sikorsky Aircraft Corporation (Sikorsky) Model S-92A Helicopters

ACTION: Notice of proposed rulemaking (NPRM).

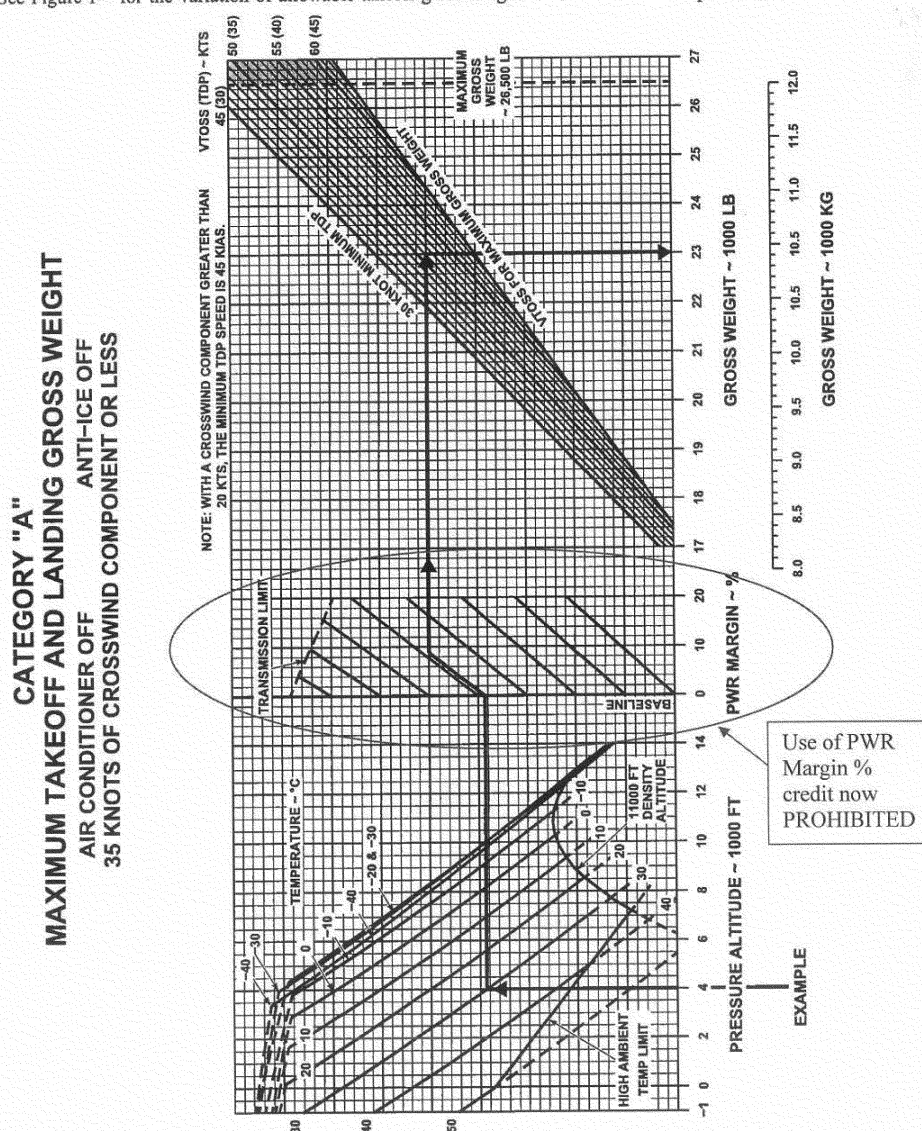
See Figure 1 for the variation of allowable takeoff gross weight with altitude and temperature.

Figure 1. Cat 'A' Takeoff and Landing Gross Weight
