#### Denial of Motor Vehicle Defect Petition, DP13–002

**ACTION:** Denial of petition for a defect investigation.

**SUMMARY:** This notice states the reasons for denying a Defect Petition (DP) (DP 13–002) submitted under 49 CFR parts 552 by Ms. Jessie A. Powell of Middleboro, MA (petitioner) in a January, 2013 letter to the Administrator of NHTSA (the “Agency”). The petitioner requested that the Agency open an investigation into software and brake failures on model year (MY) 2012 Toyota Prius C vehicles (the “Subject Vehicles”).

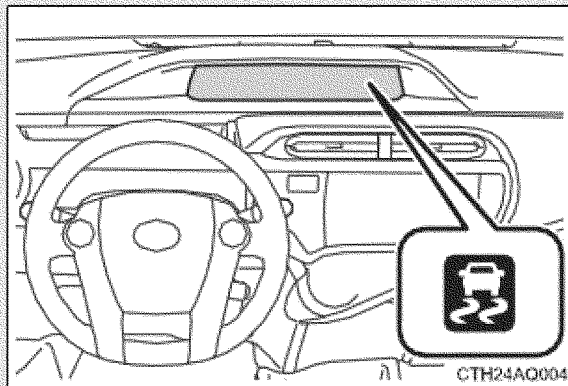
Owner's Manual (p. 222 – 223):

**Assists with starting off and temporarily maintains braking power even if the foot is removed from the brake pedal when starting off on an incline or a slippery slope.**

To engage hill-start assist control, further depress the brake pedal when the vehicle is stopped completely.

A buzzer will sound once to indicate the system is activated. The slip indicator will also start flashing.

- While hill-start assist control is operating, the brakes remain automatically applied after the driver releases the brake pedal. The stop lights and the high mounted stoplight turn on.
- Hill-start assist control operates for about 2 seconds after the brake pedal is released.
- If the slip indicator does not flash and the buzzer does not sound when the brake pedal is further depressed, slightly reduce the pressure on the brake pedal (do not allow the vehicle to roll backward) and then firmly depress it again. If the system still does not operate, check that the operating conditions explained above have been met.
