**SUMMARY:** We are adopting a new airworthiness directive (AD) for Pacific Aerospace Limited Model FU24–954 and FU24A–954 airplanes. This AD results from mandatory continuing airworthiness information (MCAI) issued by an aviation authority of another country to identify and correct an unsafe condition on an aviation product. The MCAI describes the unsafe condition as cracking of the control column at the wiring access hole, which could lead to loss of control. We are issuing this AD to require actions to address the unsafe condition on these products.

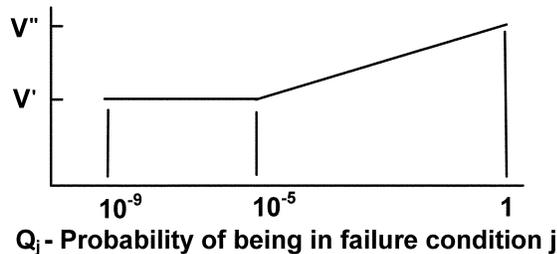
**Figure 3: Clearance speed**

$V'$  = Clearance speed as defined by § 25.629(b)(2).

$V''$  = Clearance speed as defined by § 25.629(b)(1).

$Q_j = (T_j)(P_j)$  where:

$T_j$  = Average time spent in failure condition  $j$  (in hours).

$P_j$  = Probability of occurrence of failure condition  $j$  (per hour).

Note: If  $P_j$  is greater than  $10^{-3}$  per flight hour, then the flutter clearance speed must not be less than  $V''$ .

(vi) Freedom from aeroelastic instability must also be shown up to  $V'$  in Figure 3 above, for any probable system failure condition combined with any damage required or selected for investigation by § 25.571(b).

combined probability of being in the dispatched failure condition and the subsequent failure condition for the safety margins in Figures 2 and 3. These limitations must be such that the probability of being in this combined failure state and then subsequently encountering limit load conditions is extremely improbable. No reduction in these safety margins is allowed if the subsequent system failure rate is greater than  $10^{-3}$  per hour.
